Large Erecting Shed, Eveleigh NSW

Assessment of Adequacy – Structure and Electrical Services

Project no: 20618

April 2006

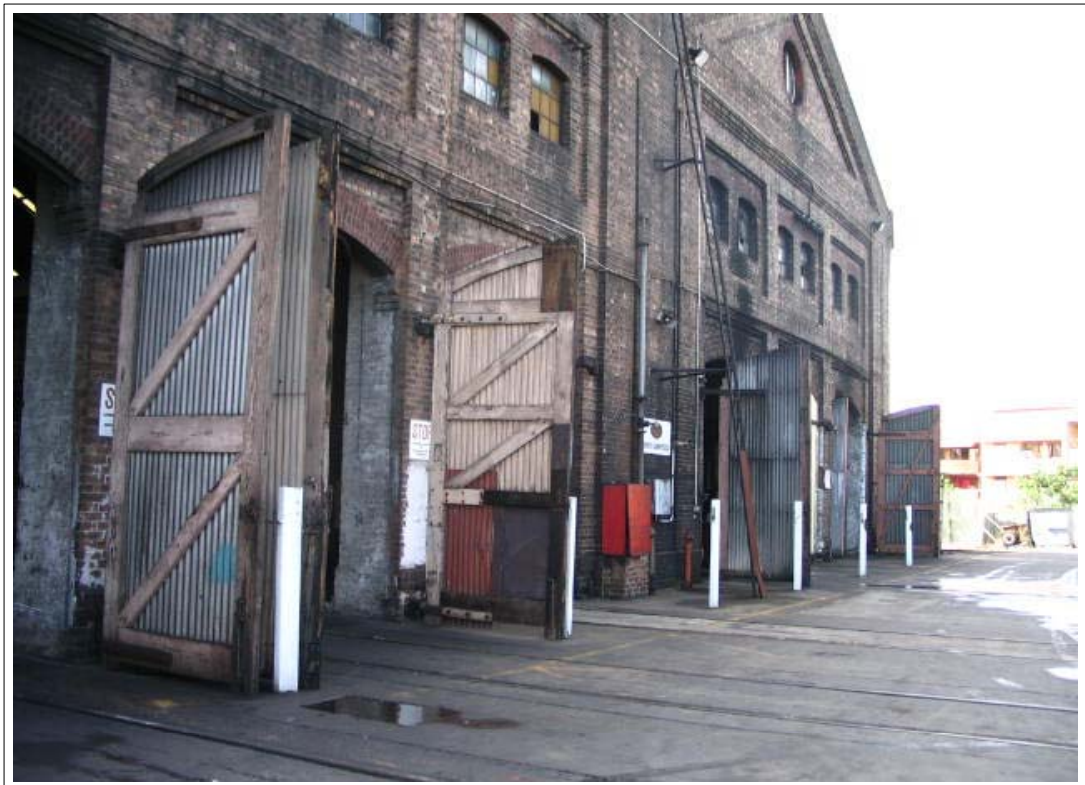
The six large pairs of main entrance doors to the west and east elevations (for locomotive access) comprise timber framed, ledged, braced and boarded hardwood doors hinged to the brickwork walls via built in metal cup and socket heavy duty hinges. The majority of these doors are in a very dilapidated condition.

These entrance doors have undergone various ad-hoc repairs over the past and the timber boarding has been overlapped / replaced with galvanised corrugated sheeting. The hinges have surface corrosion and require repair. We would recommend you budget for the complete extensive overhaul and refurbishment of the doors.

2 Main entrance doors to the Western front elevation.

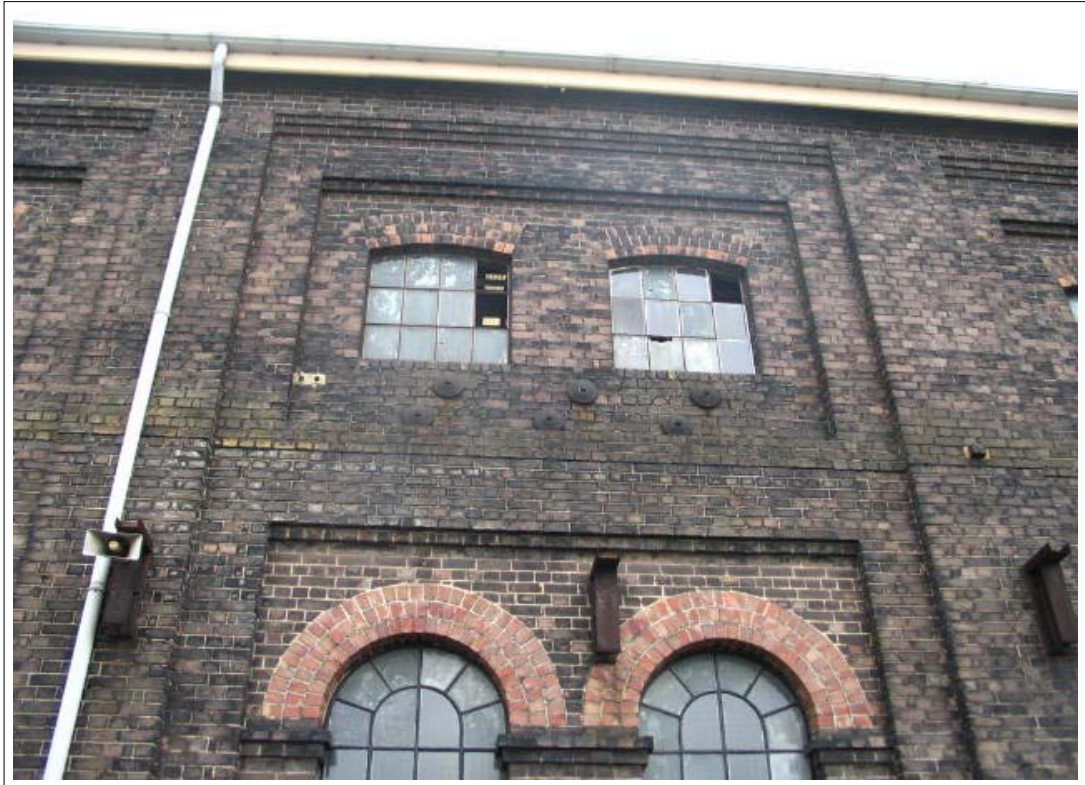
The high and low bay window frame construction comprises of metal casements/ frames and louvred opening casement lights, with feature bullseye window to the high level gable walls. There are numerous occurrences of damaged window panes and corrosion to the frames requiring full repair and refurbishment.

7 South elevation. General missing window panes.

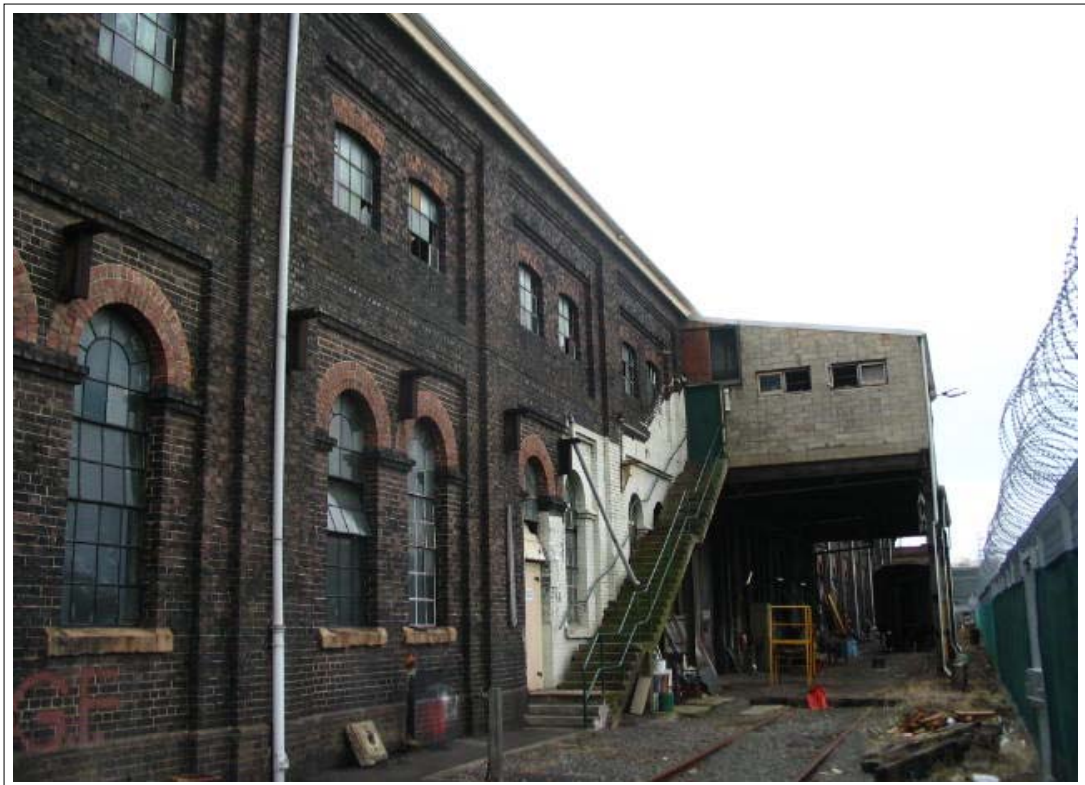
The extension is supported off steel structural beams that are showing signs of surface corrosion. Further investigation is recommended to these beams. The building construction is poor with loose and dangerous block work to the west side of the building requiring urgent attention. The handrails are open and in need of renewal and there is some minor spalling of the concrete stairs.

8 Dilapidated first floor extension to South elevation.

Given the condition of this extension we would recommend that this ad-hoc addition be removed and the main building be made good.

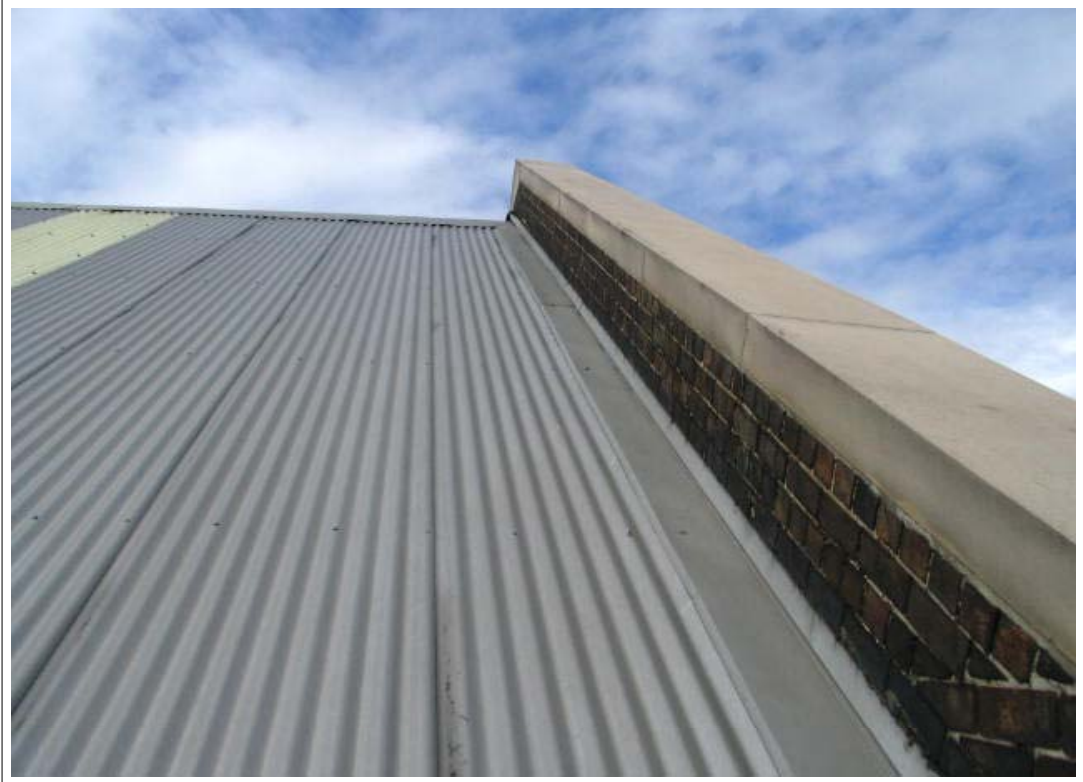
The metal flashing at the junction of the western front elevation and roof sheeting was in good condition where inspected.

11 Roof flashing in good order.

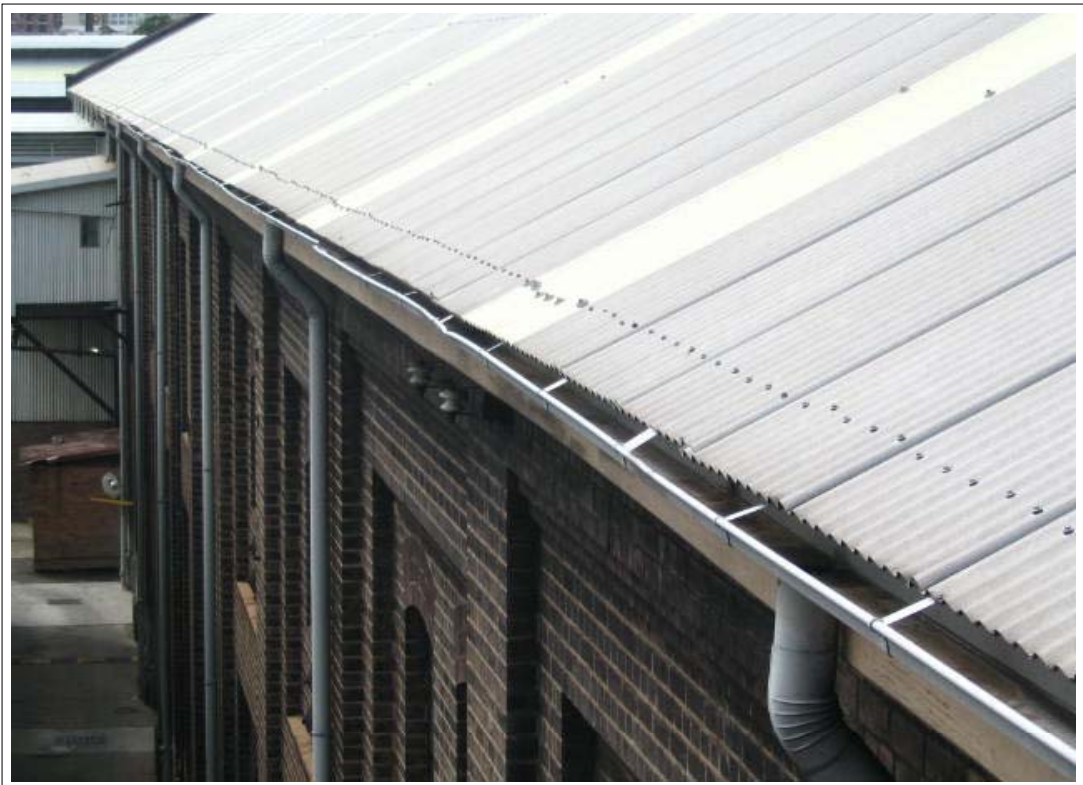
The perimeter gutters where inspected to the north elevation are generally in good condition, although in need of some repair where a number of brackets are broken and the gutter line is somewhat displaced.

12 Roof gutter requires realignment.

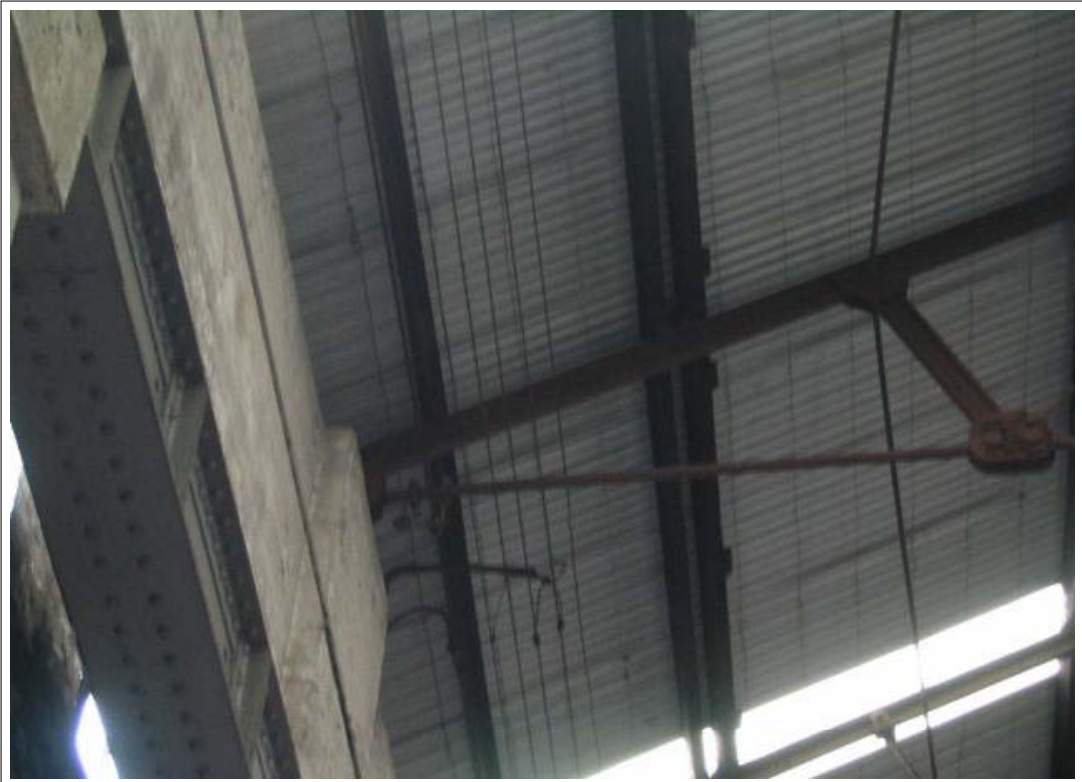
- The main roof trusses have tension rod bottom chords. This design is inadequate for any possible upward loading due to wind loads.
- The under-purlins similarly have a tension rod as the bottom chord and similar comments in relation to any possible upward wind loads apply.

14 End truss to North side. Note exposed electrical cables and slender bottom truss rod.

The roof trusses could be stiffened by adding a member to the bottom chord that will be sufficient for the upward loading. Similarly, should other members be deficient then these could also be stiffened.

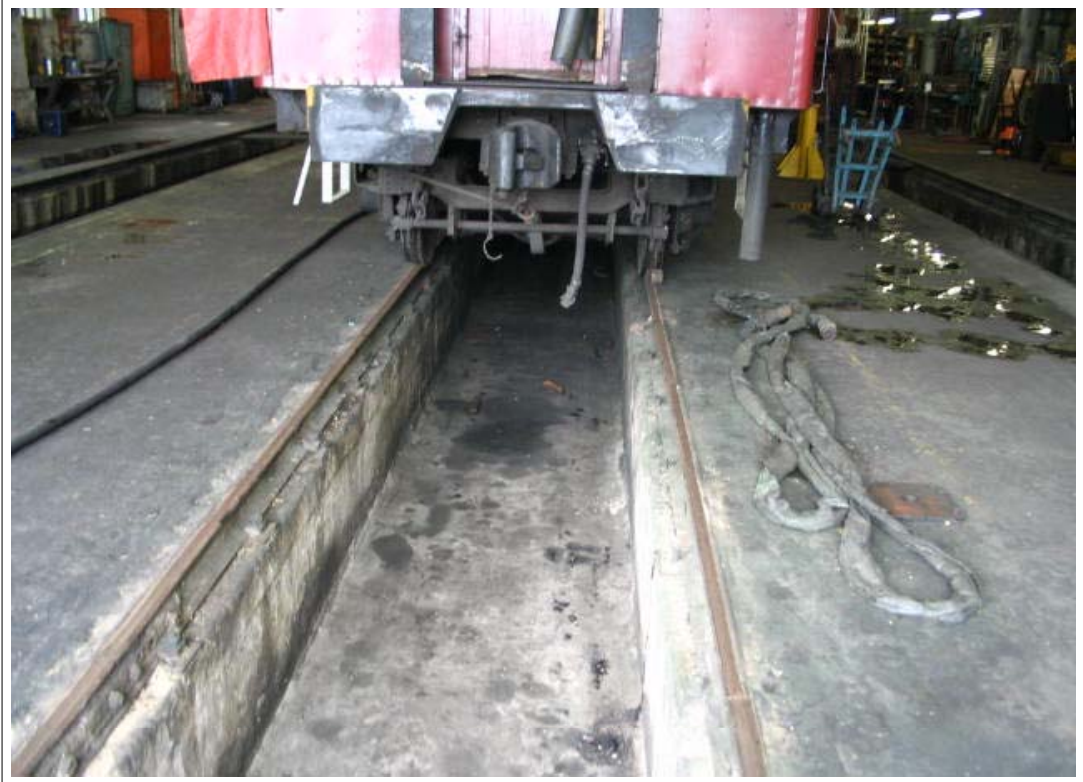
There inspection pits could not be safely accessed due to rolling stock over. The service pits have accumulated grease, oil, mechanical fluids, rubbish, etc. over time which could possibly cause a fire / chemical hazard. Consideration needs to be given to their continued use by way of a health and safety risk assessment being undertaken. In the short time we would recommend the grease, oil and mechanical fluids accumulation be chemically removed, collected and removed from the service pits.

17 Open internal inspection pits.

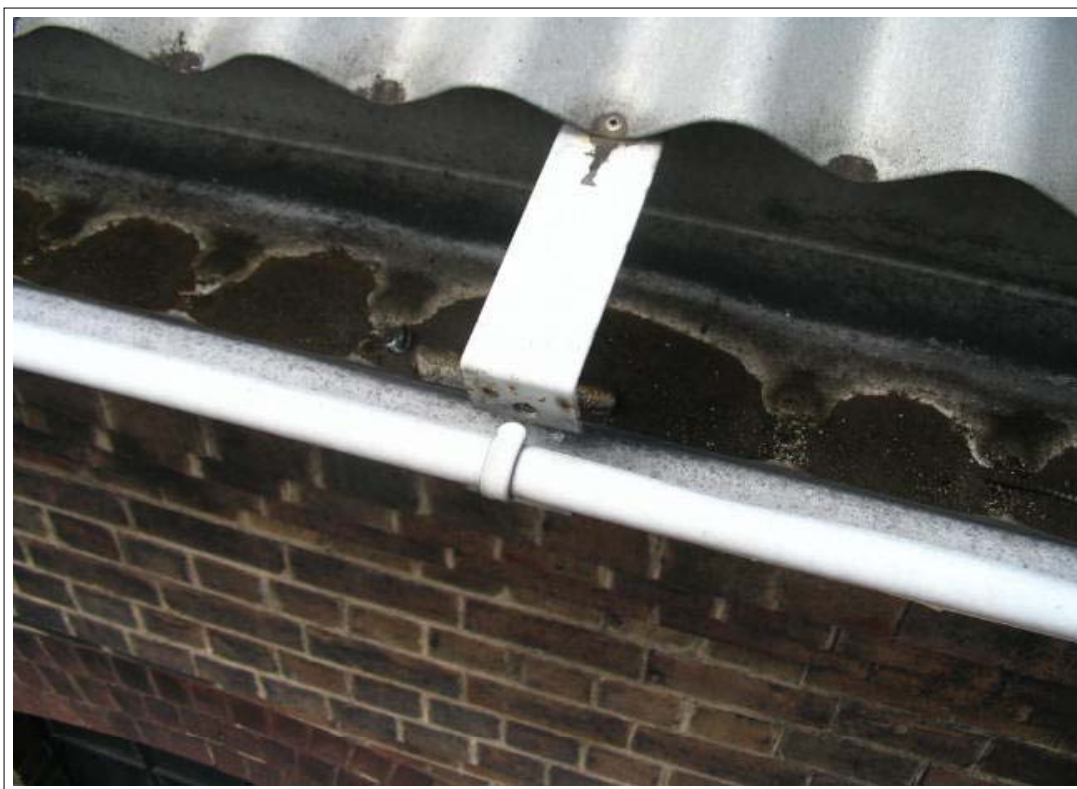
20 Broken gutter fixing bracket.

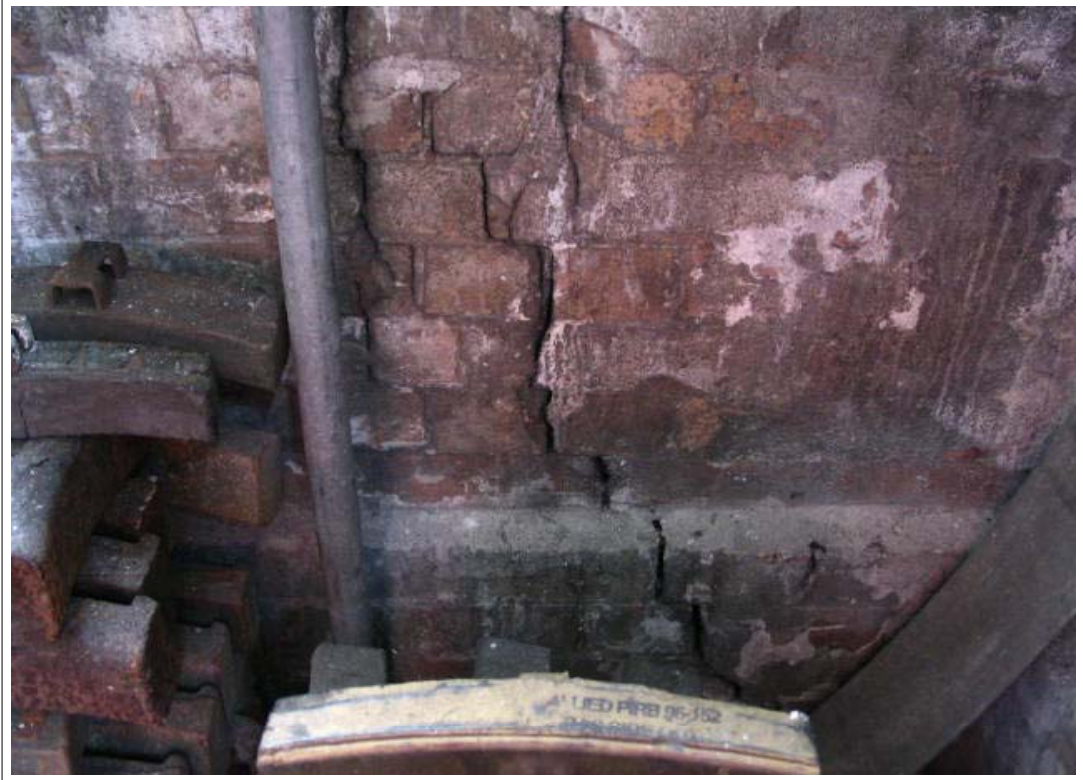
21 Internal cracking to bay 1 of the Southern wall.

- Rake out and re-point to 25mm in cement / lime mortar areas of damaged brickwork.
- Large cracks to perimeter walls are to be cut and replaced with new stock bricks to match existing. Cracks to be tied with stainless steel rods.
- Smaller cracks where bricks are not damaged are to be raked out and re-pointed to match.
- Possible part reconstruction of damaged brick arch to rear door opening to east elevation.
- Cut out and replace damaged/cracked bricks.
- Remove all parts of previous structures and make good back to match existing.

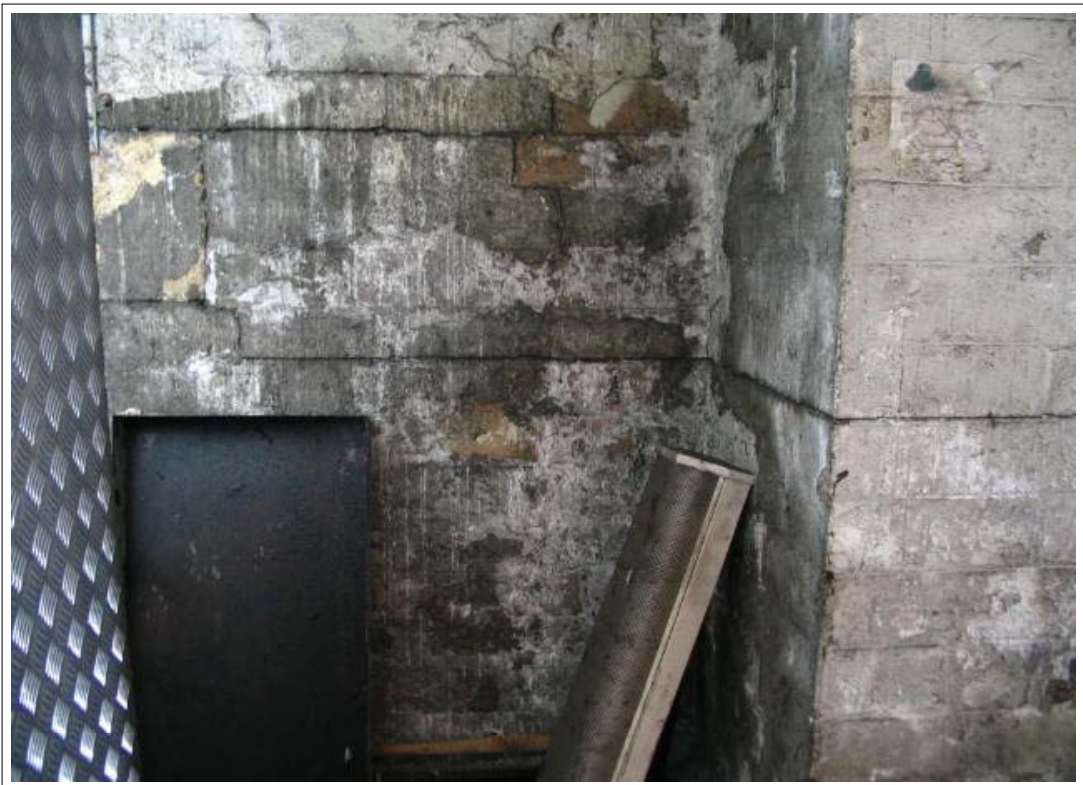
- Low level vertical cracking to south elevation.
- Low level horizontal crack within mortar course to south elevation within south west corner, at approx height of 900mm above floor level.

22 Low level internal horizontal crack line to Southern wall.

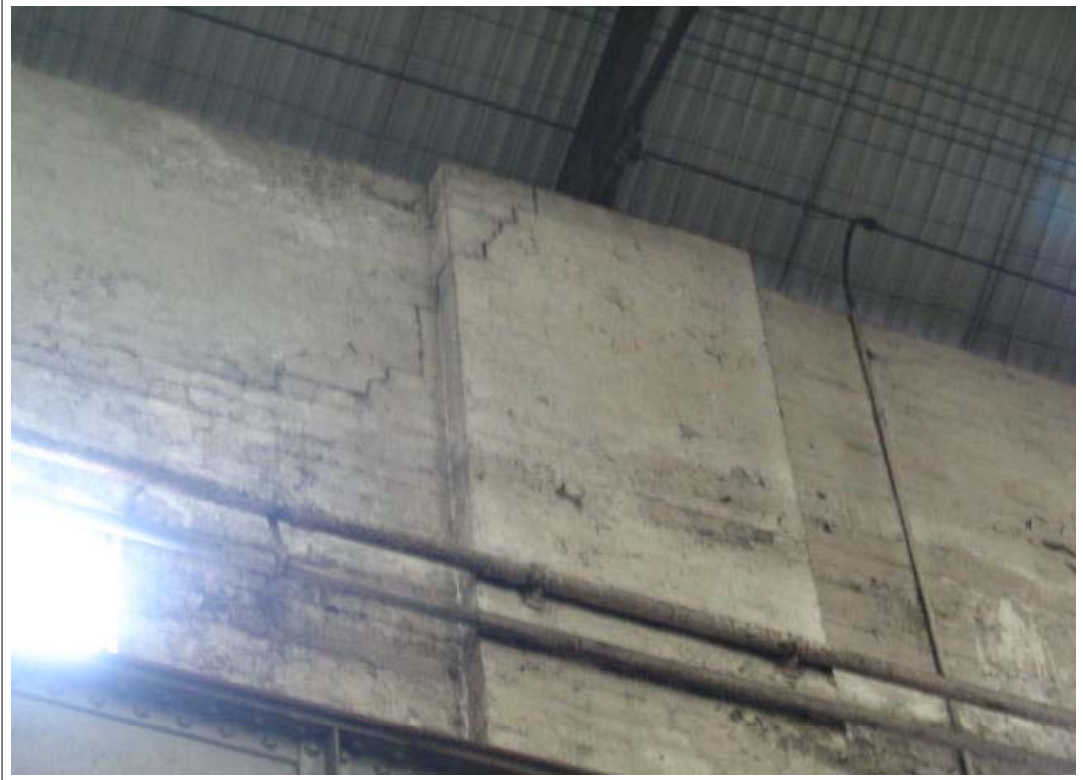
23 General high level cracking to South wall.

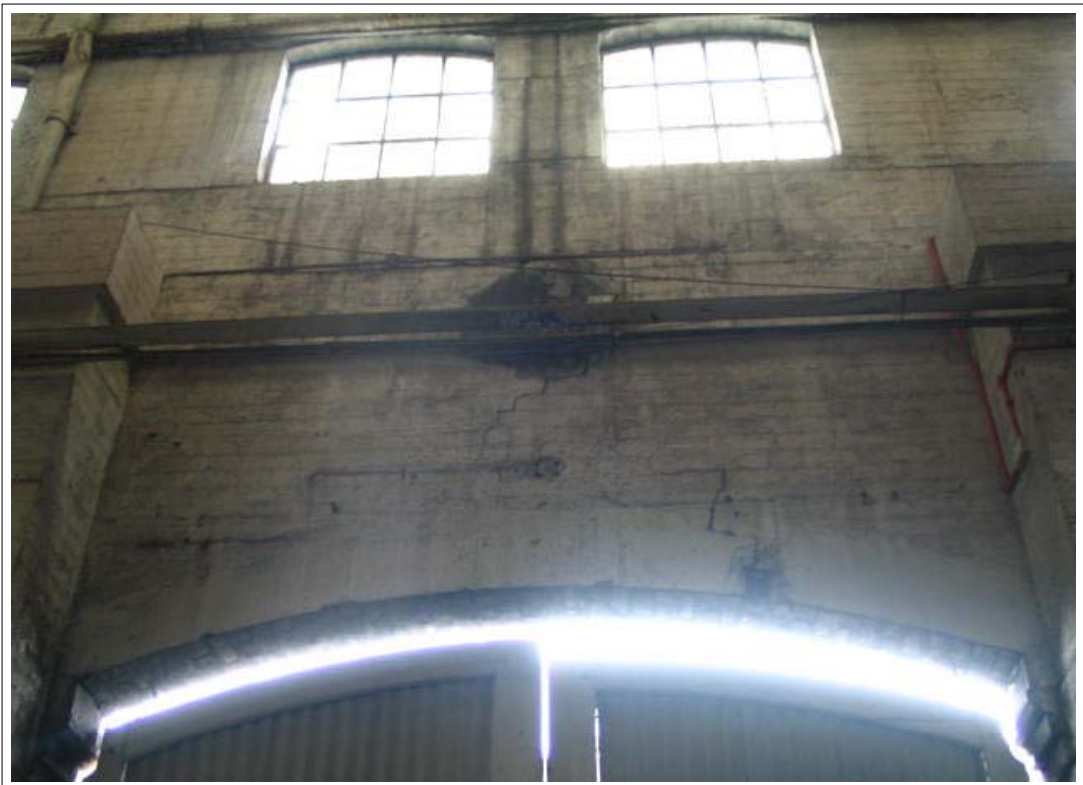
24 General cracking over Eastern rear gable wall.

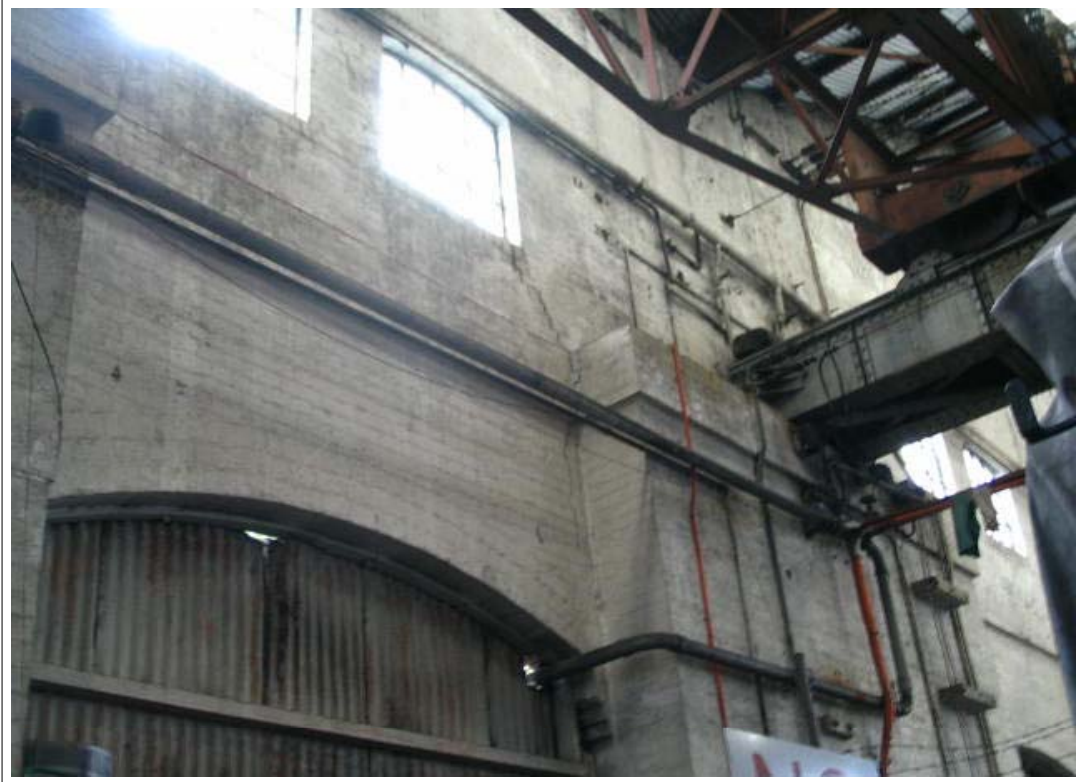
25 Stepped cracking to right hand side of rear gable window.

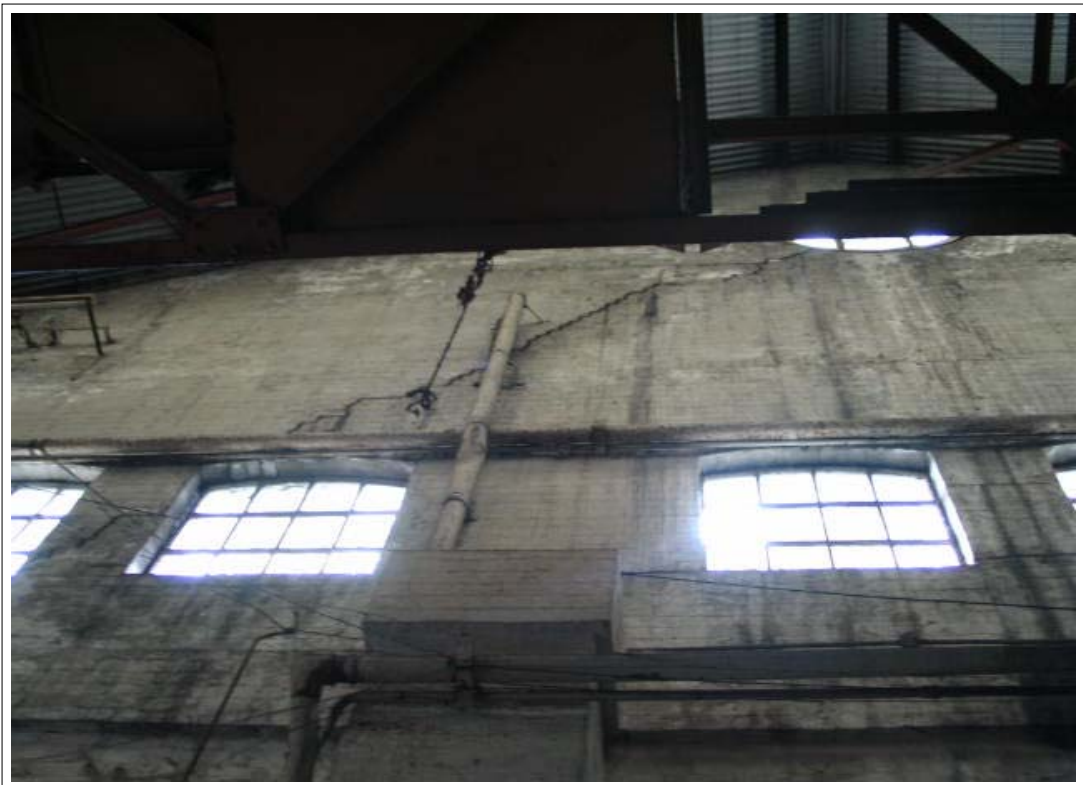
- High level vertical cracking within the external walls particularly to the north elevation.
- High level stepped vertical cracking to the rear eastern walls (north side) above the middle door opening arch. .

26 Large stepped crack to rear eastern gable wall.

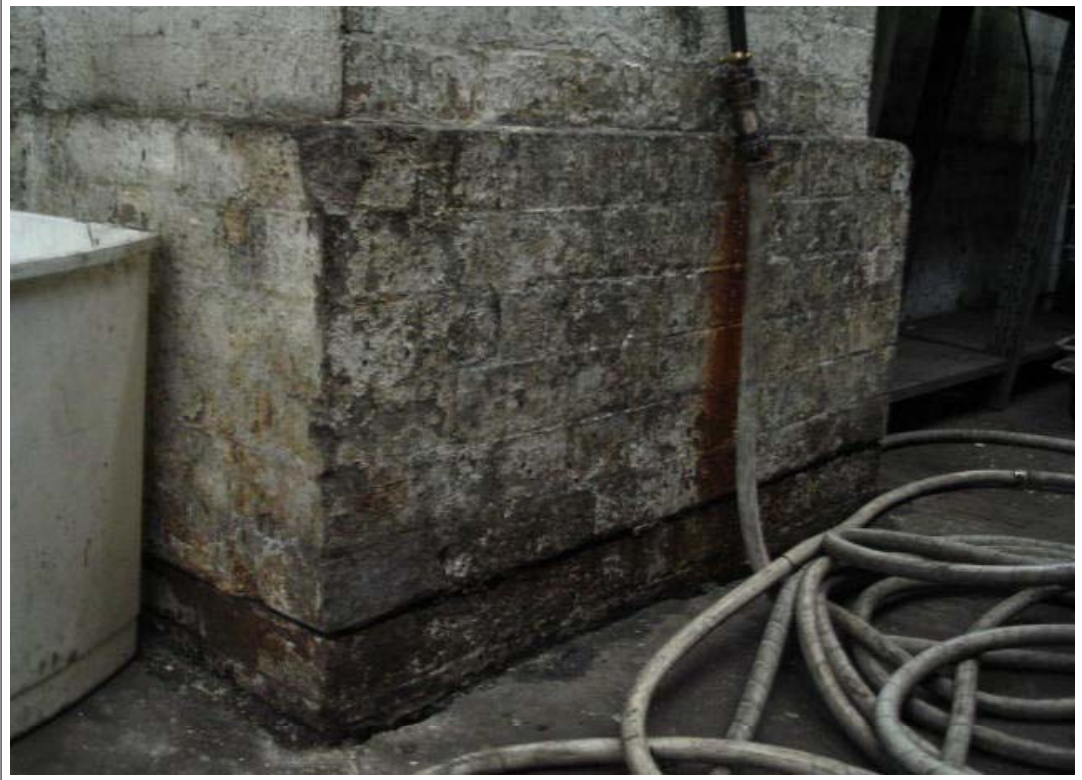
- Areas of probable impact damage to east elevation above door openings.
- Minor movement to brickwork piers at line of damp-proof course noted to north elevation.

27 Horizontal cracking / minor displacement on damp proof course line.

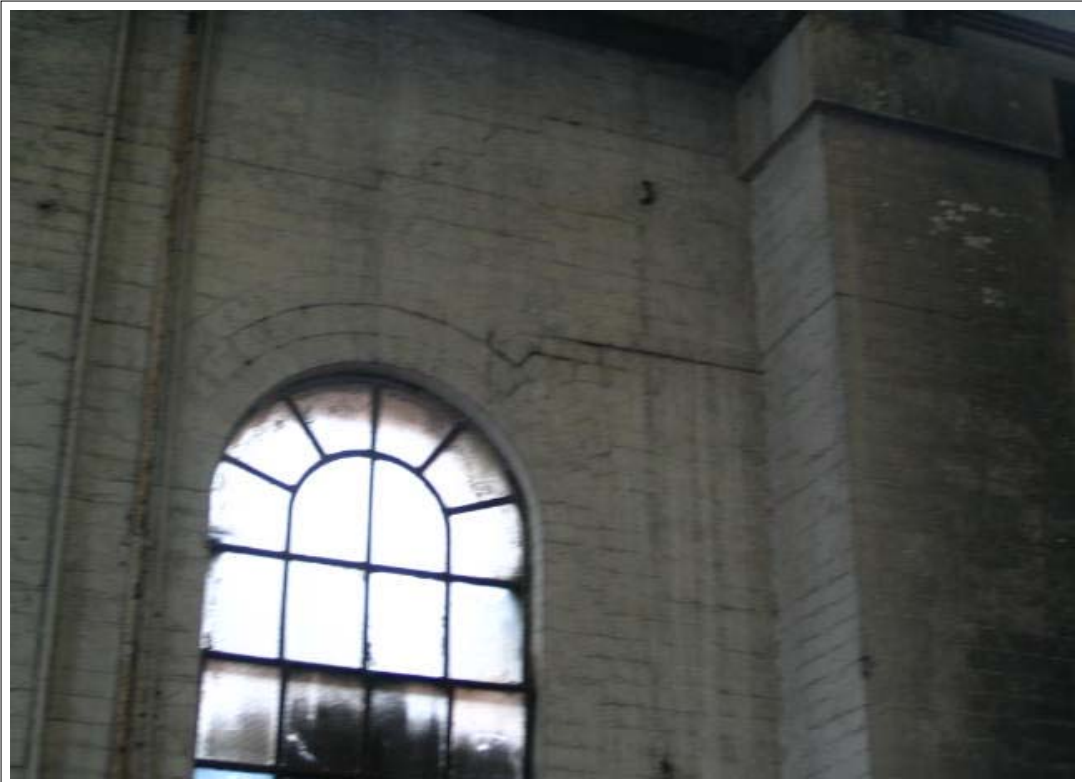
28 Horizontal cracking to the head of the window to the northern wall.

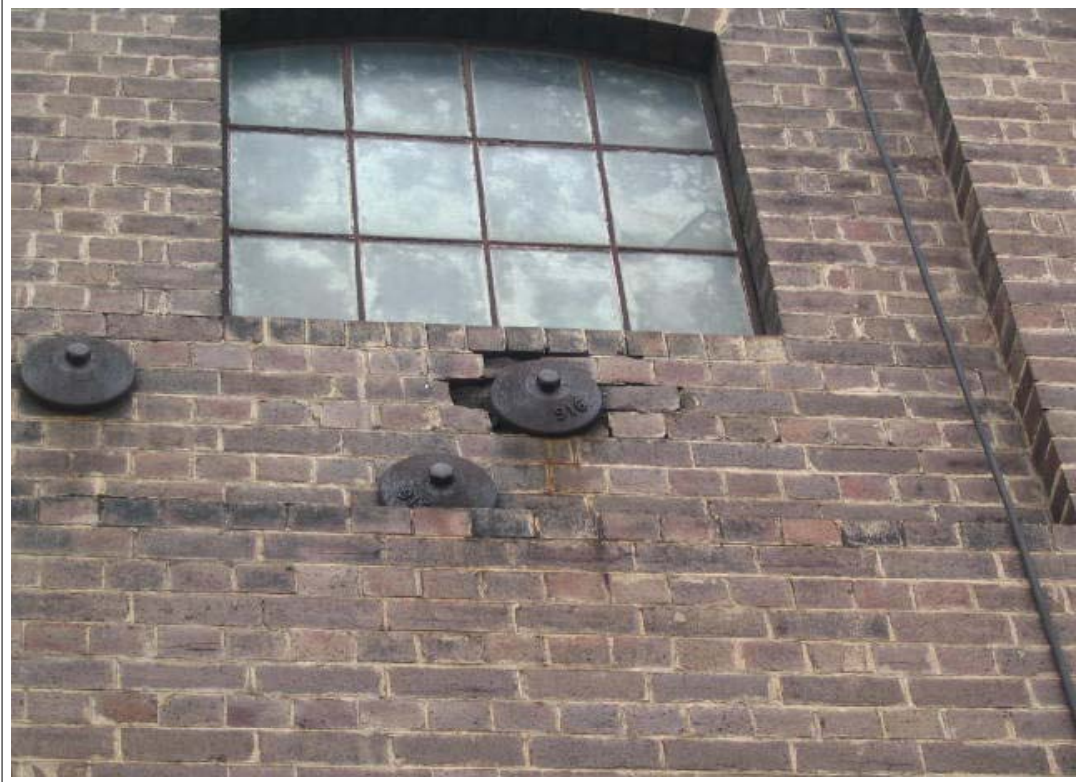
- Areas of external brickwork require raking out and re-pointing where mortar currently spalling and loose.
- Reconstruction of external brickwork where deformed by loadings from crane restraint ties to North elevation.

29 Brickwork repairs required around crane restraint fixing.

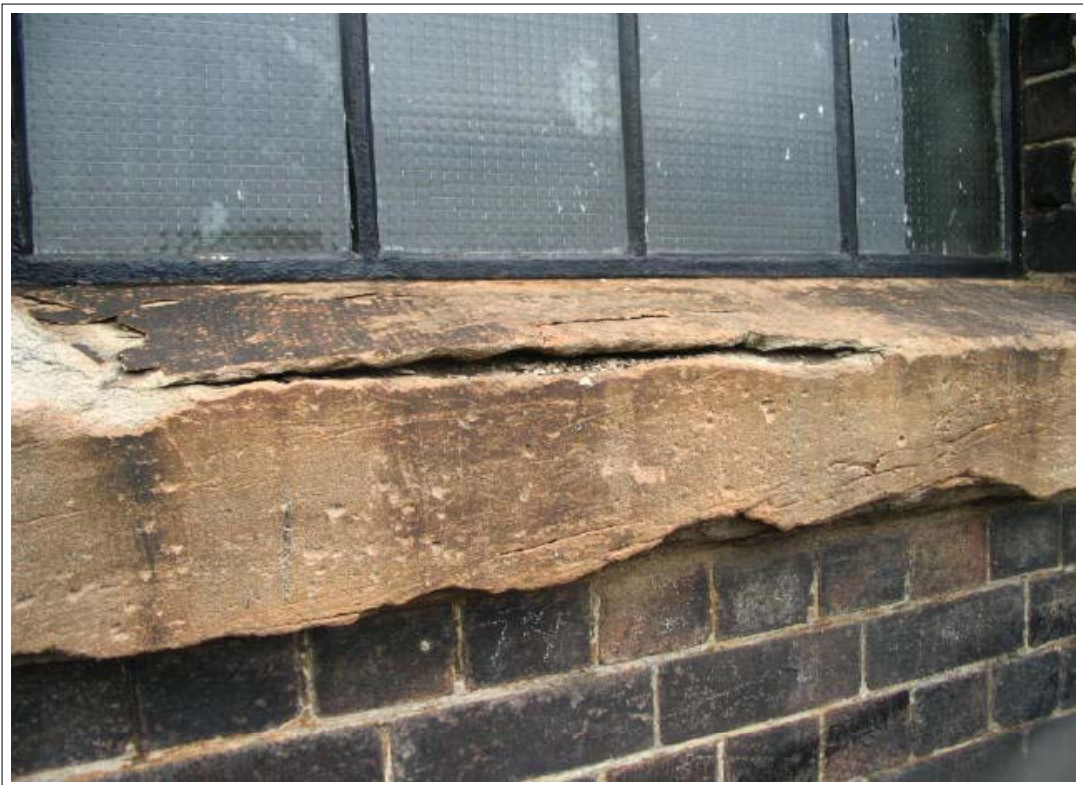
The low level window sub-cills are of sandstone construction. Many of these stone sub sills are damaged and spalling. We recommend specialist stone repairs be undertaken by way of splicing of new matching stone sections.

30 Spalling stone window sub-cill.

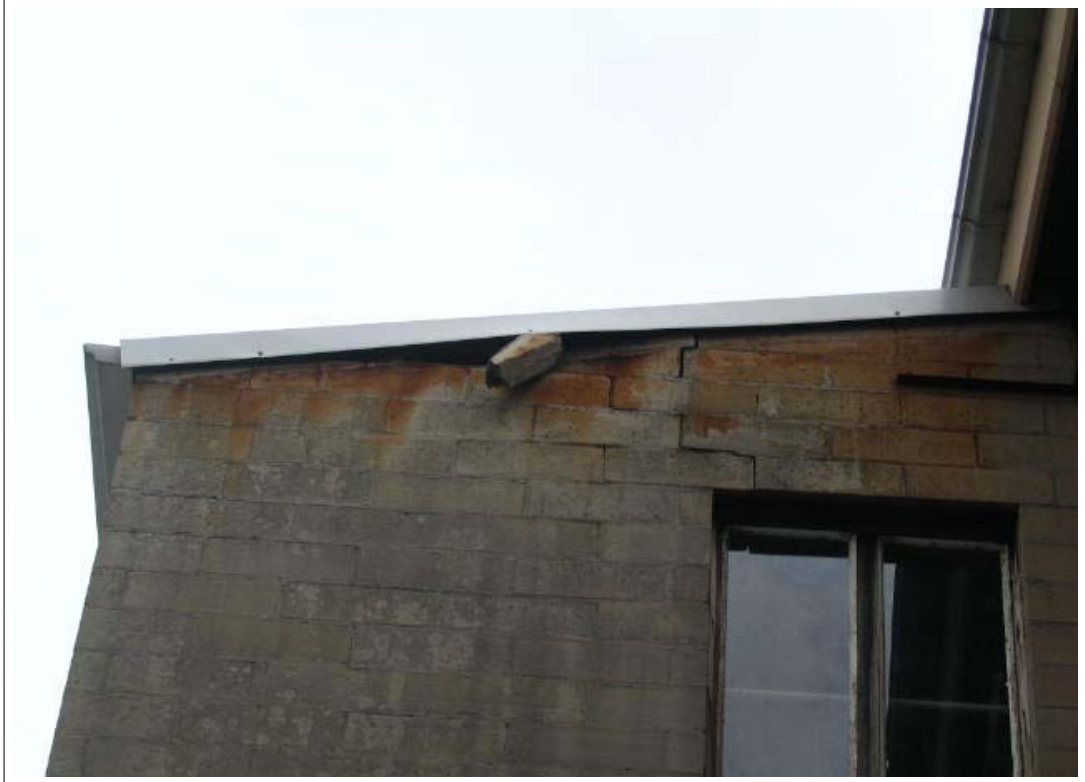
31 Loose block to South elevation.

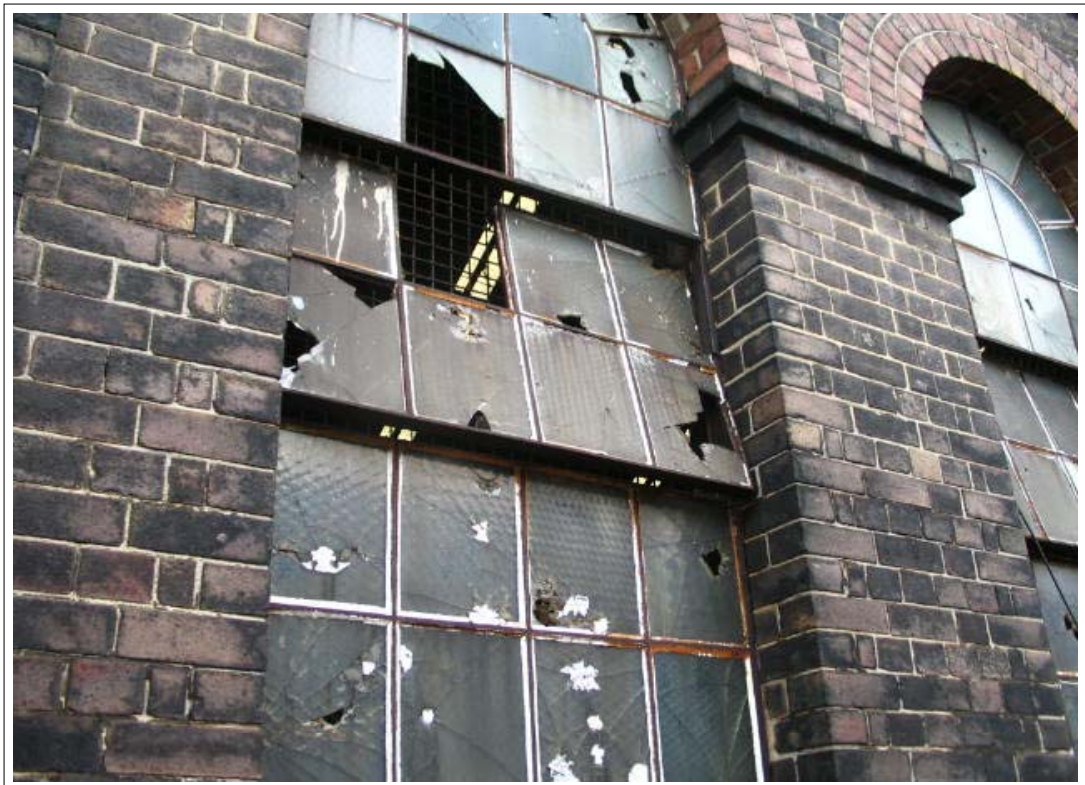
32 General condition of windows.

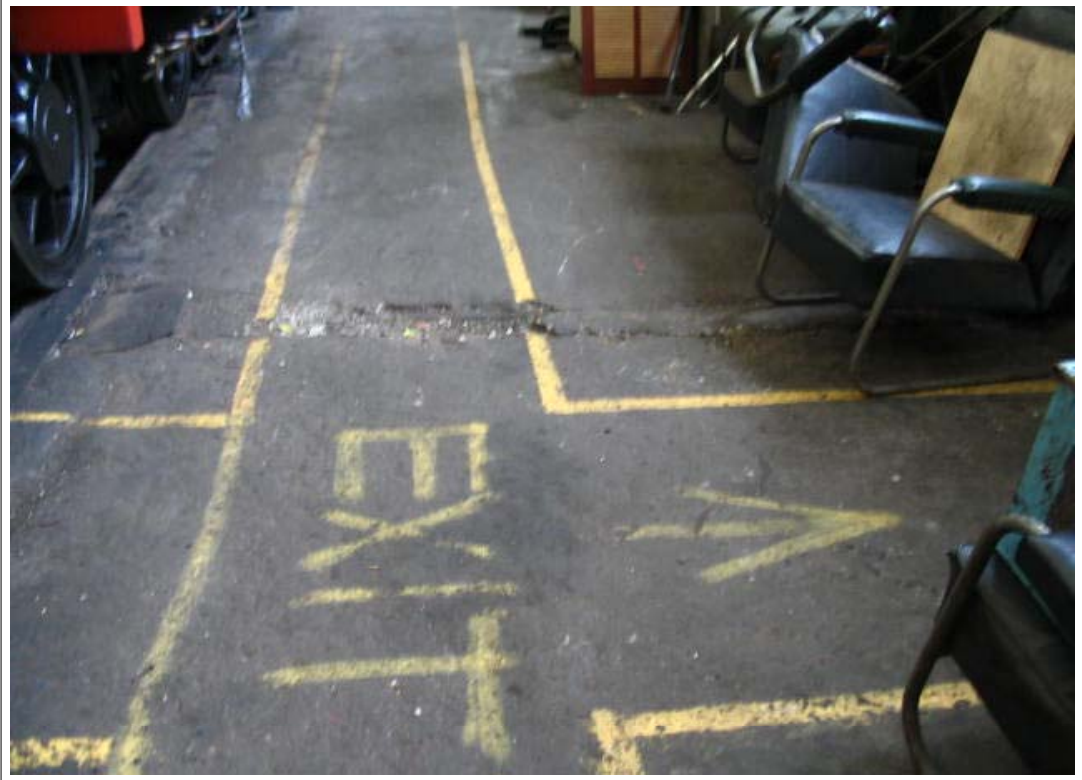
Service conduits laid in the top of the slab were noted in a number of locations. These have been shallow laid with the result that the concrete infill has spalled and lifted above. If these services runs are to be retained then these cables should be ducted into the floor.

33 Floor slab displaced around service conduit.
