WATERLOO SAFETY AUDIT

Part 2 – 2015

Low Rise Buildings Safety Audit carried out by the Waterloo Wellbeing and Safety Action Group, subgroup of the Waterloo Neighbourhood Advisory Board

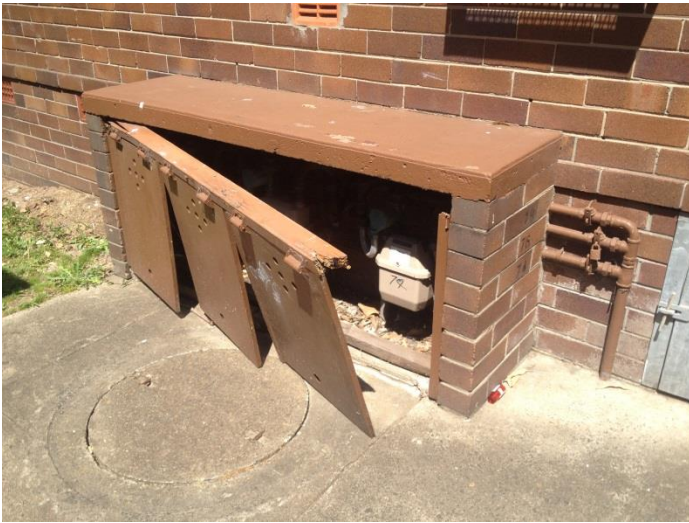
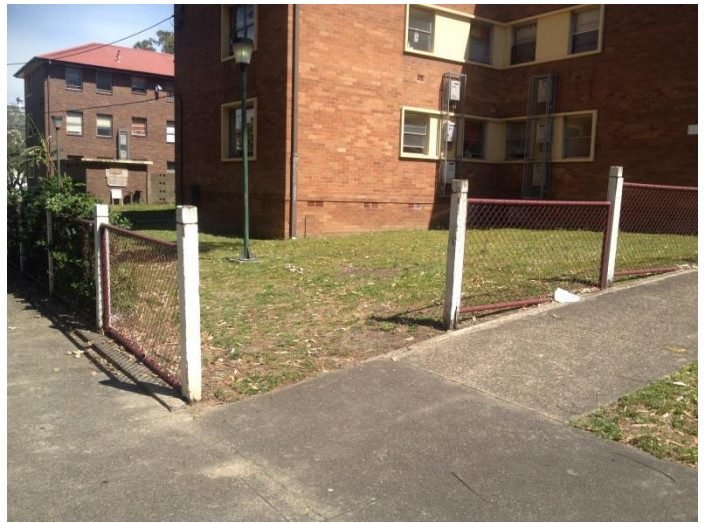
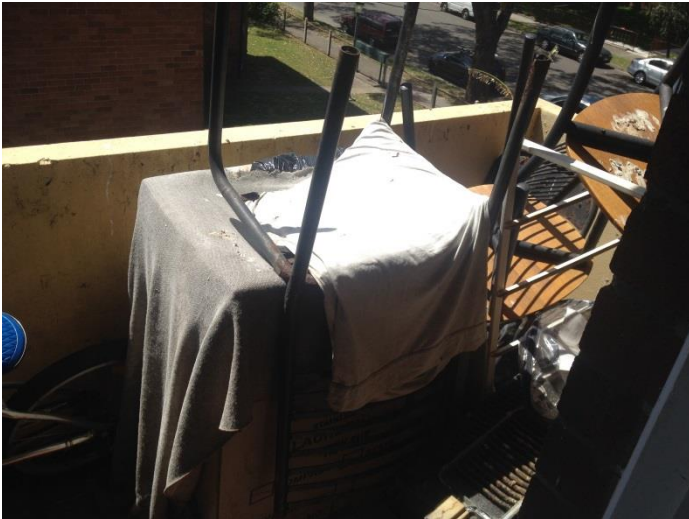
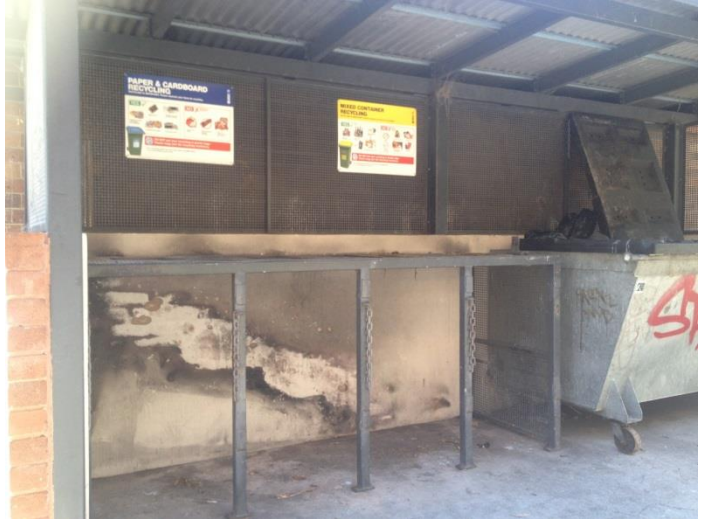
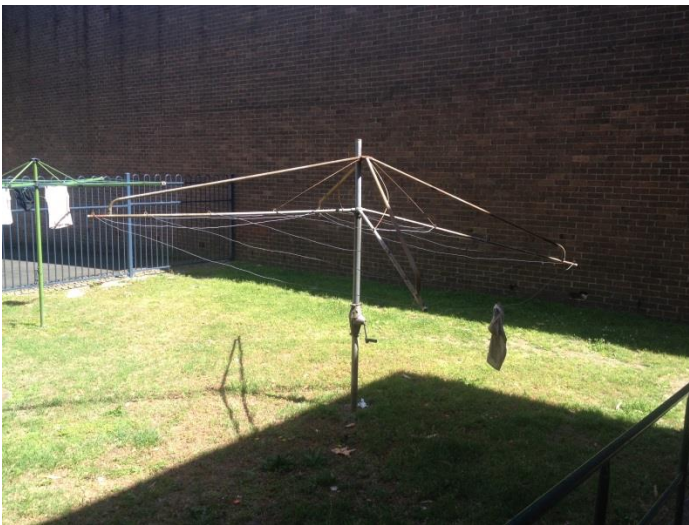
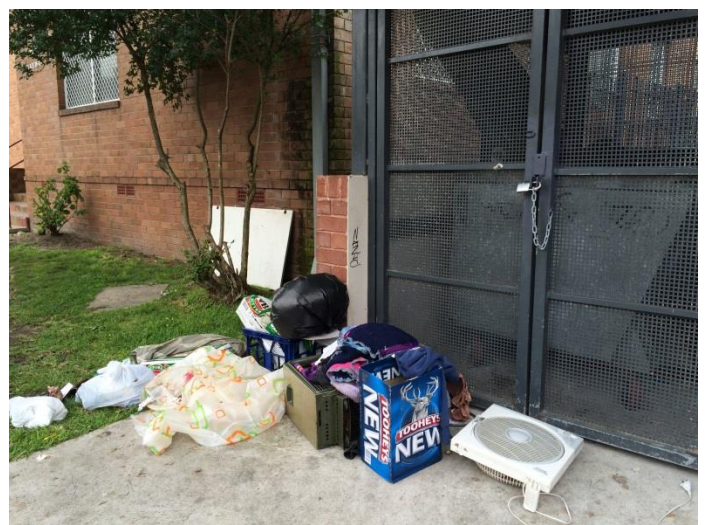
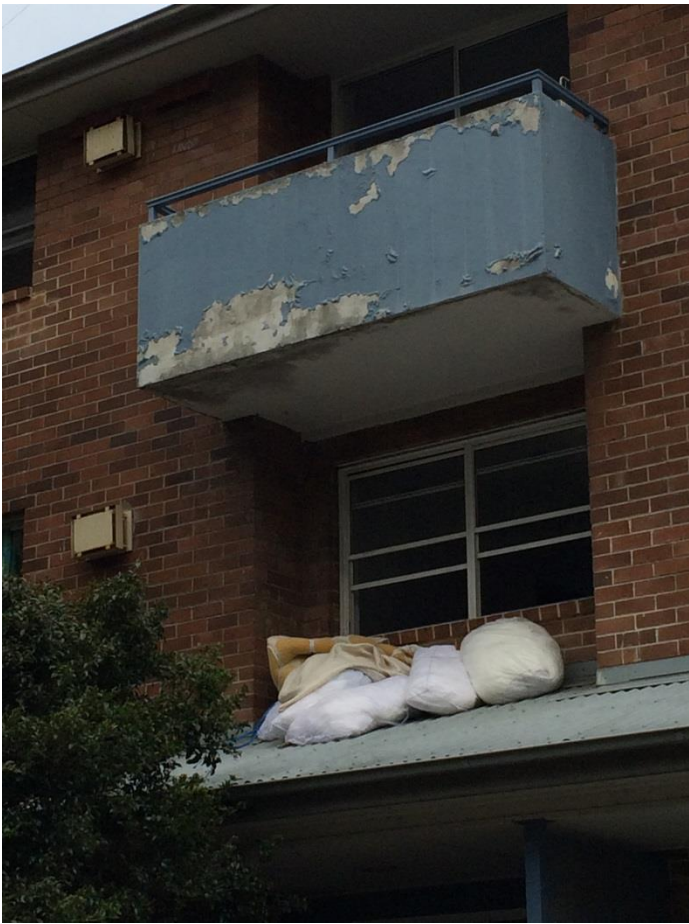
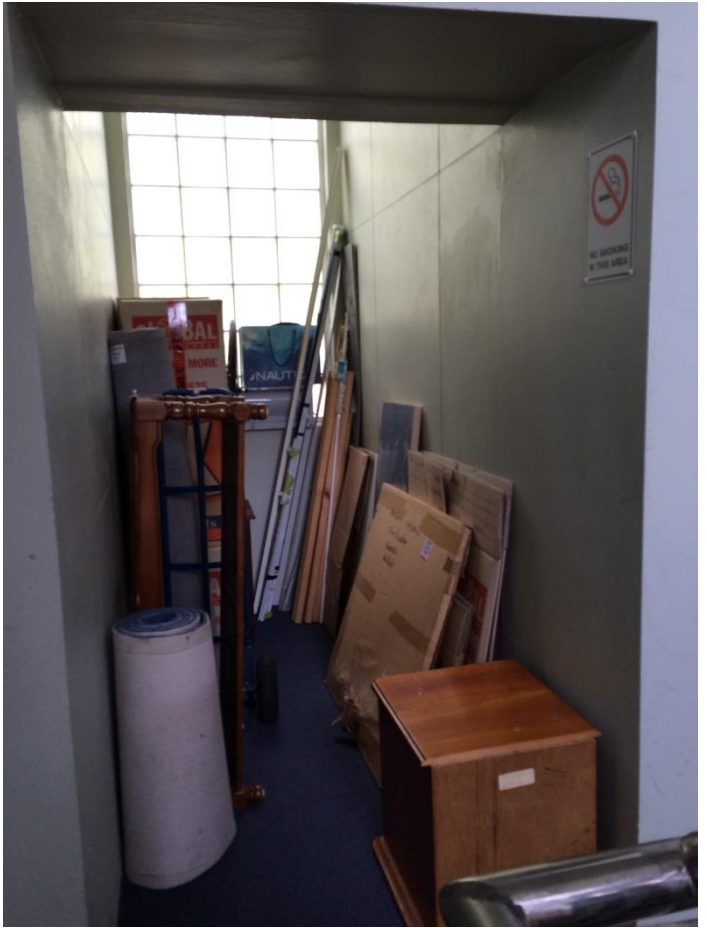
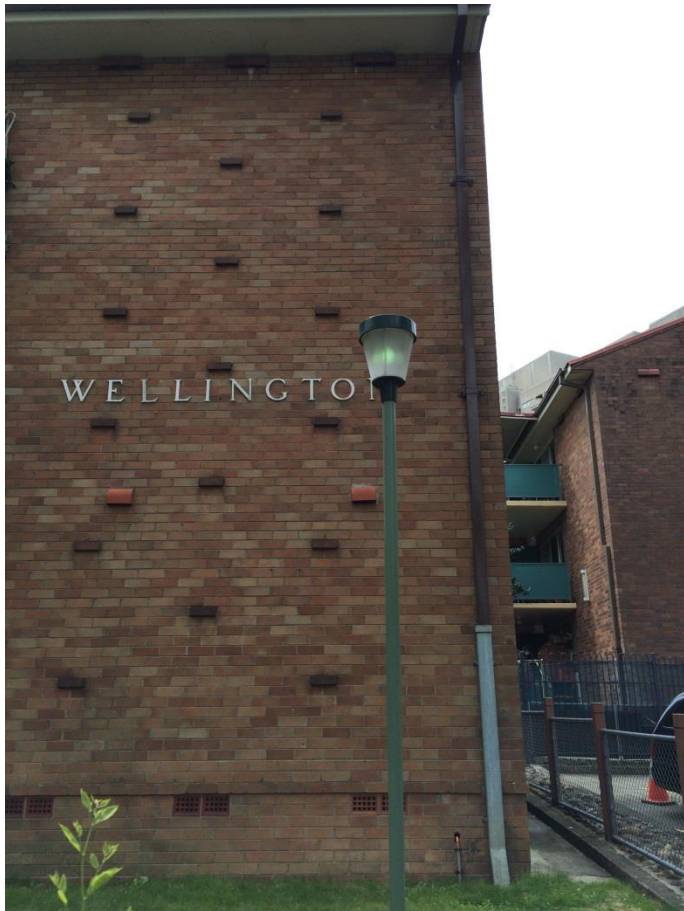
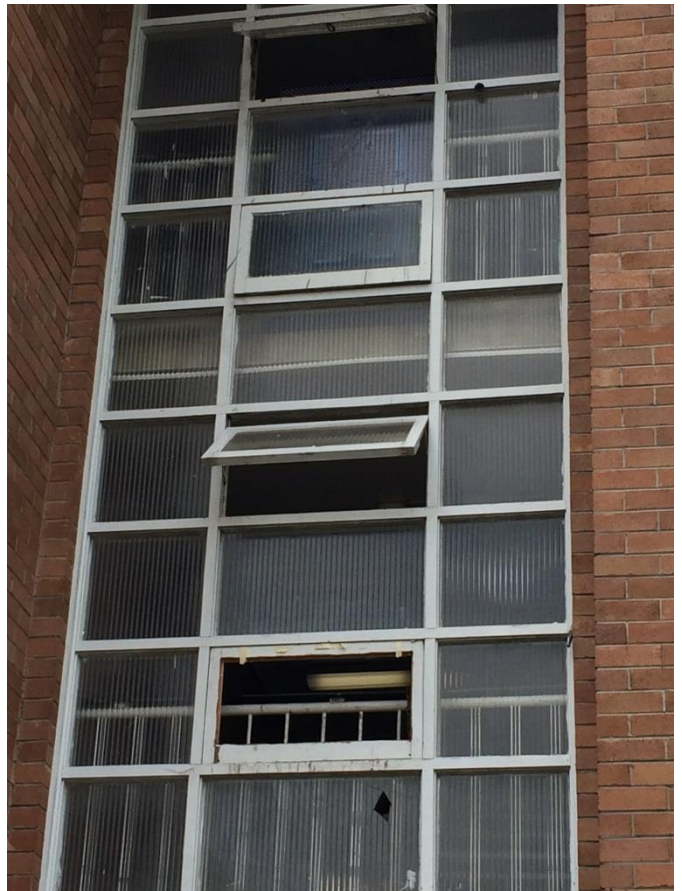
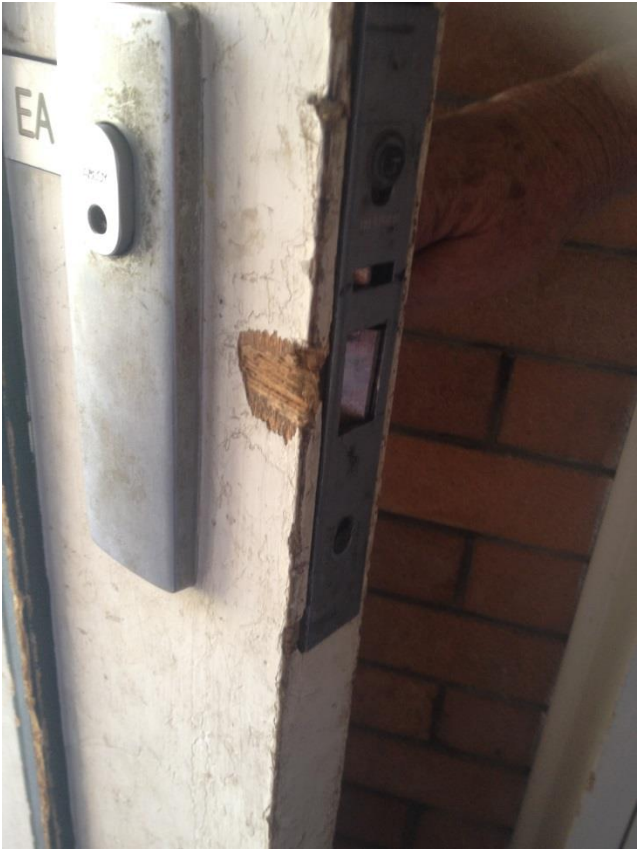
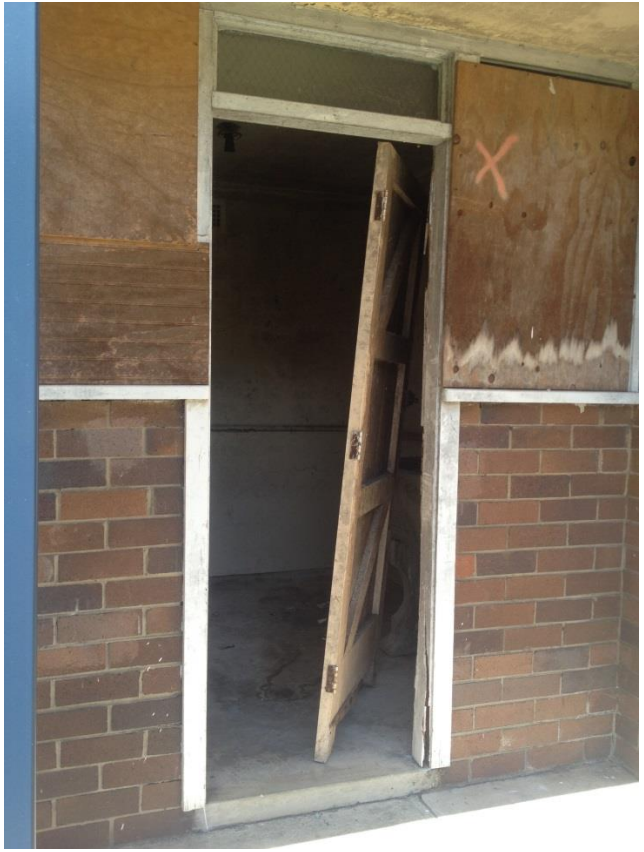
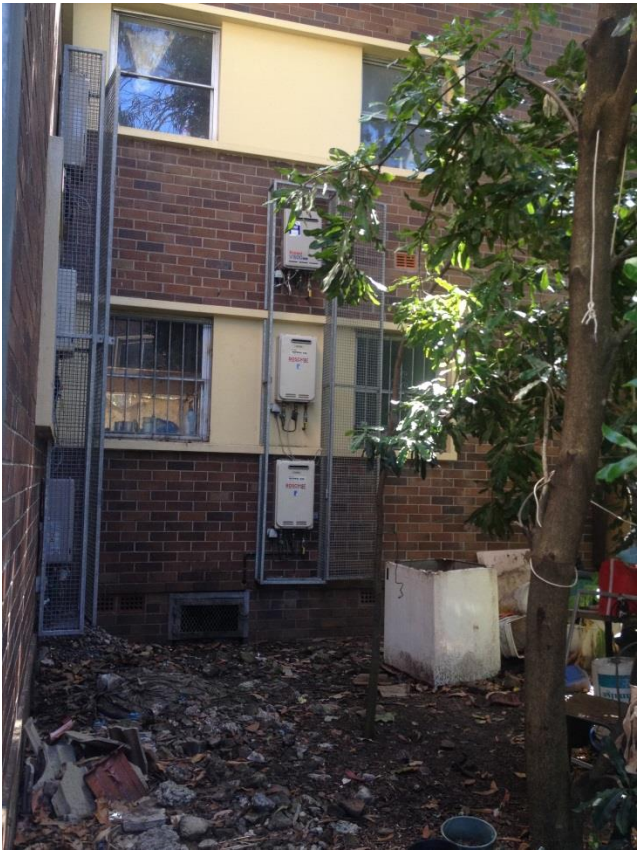
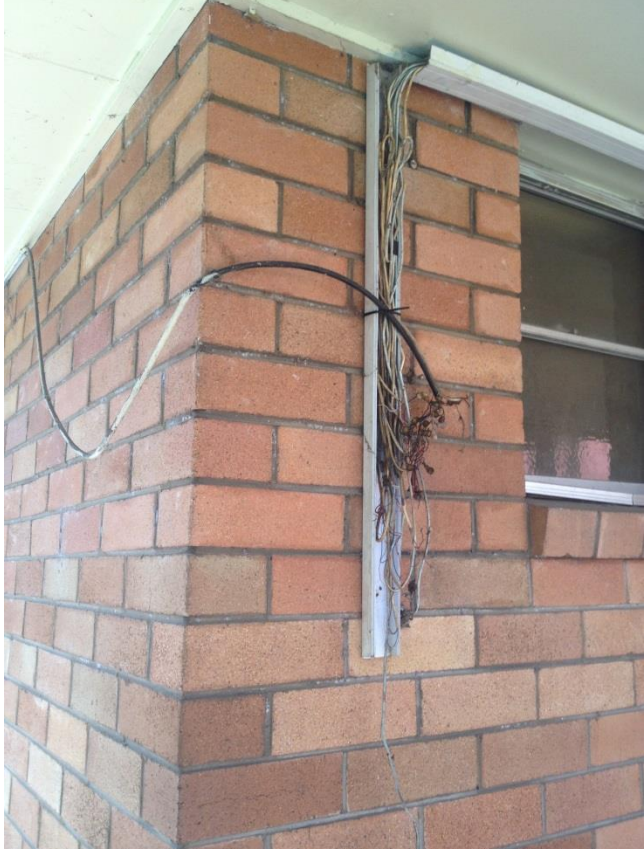
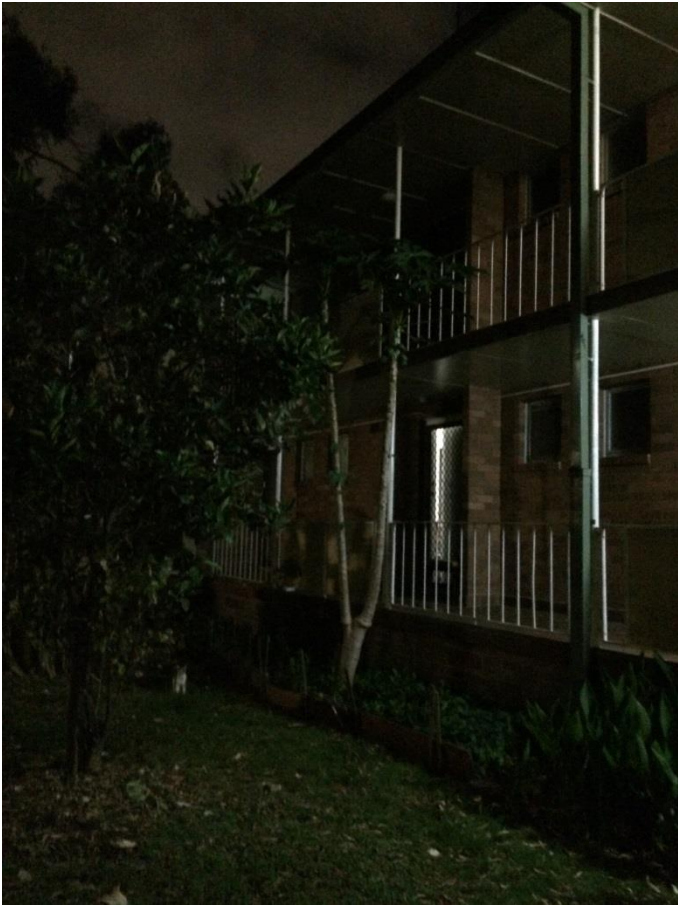
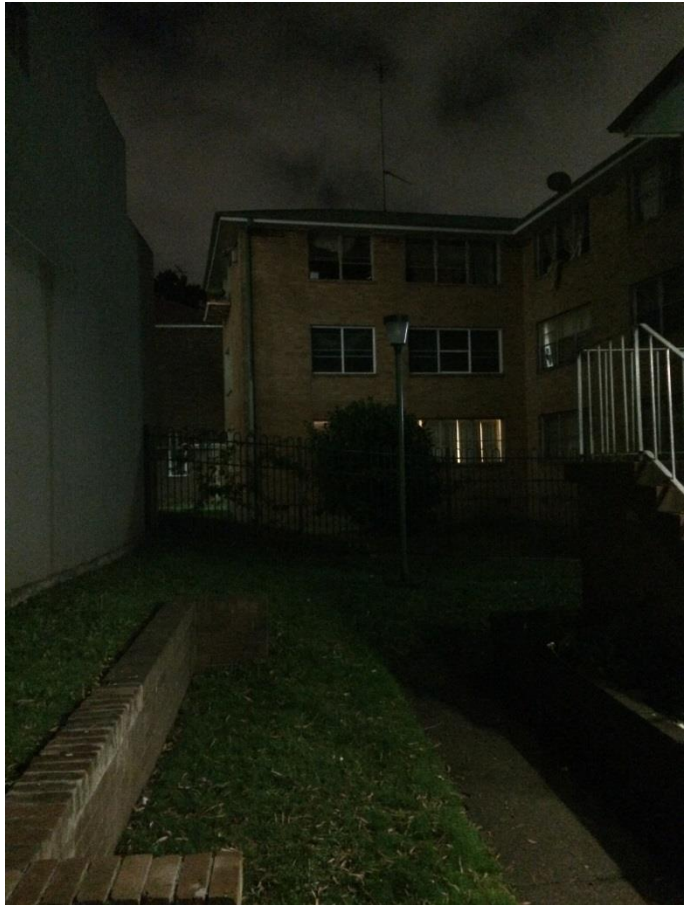
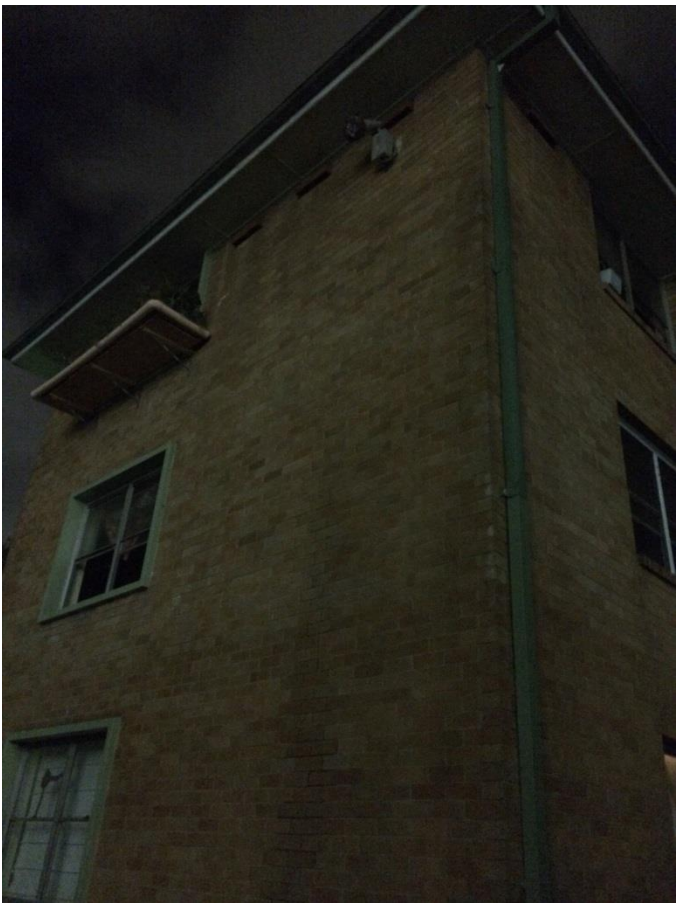
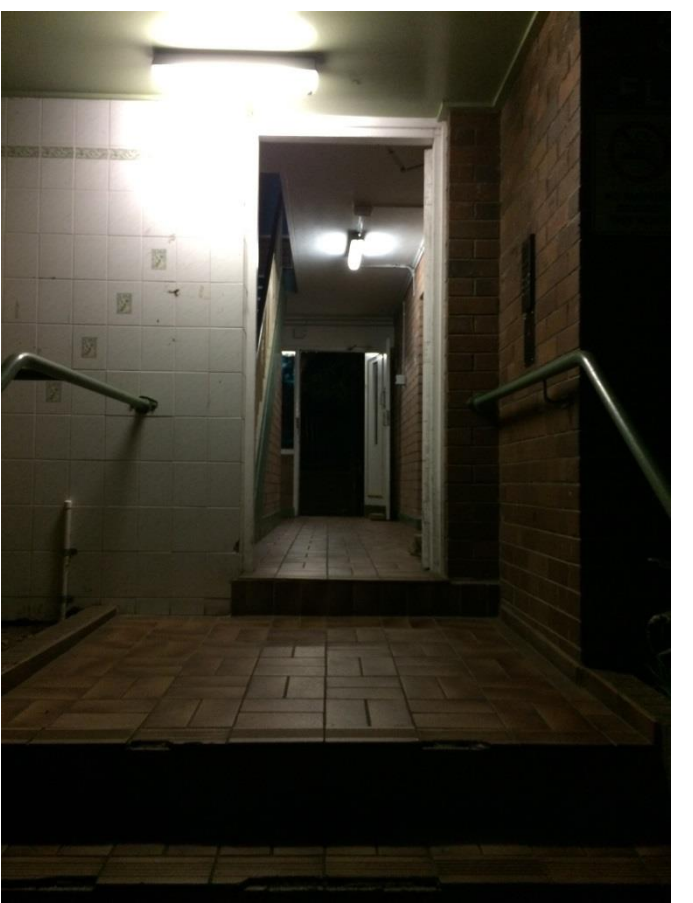
These photos highlight some of the problem issues and spots in the audit precincts. There are other spaces that are well maintained and valued by local tenants. A number of problems are generated from vandalism, waste management and anti-social activities.
