Redfern Local Area Command  
**Waterloo Green Safety Audit**  
14 June 2007

# Executive Summary

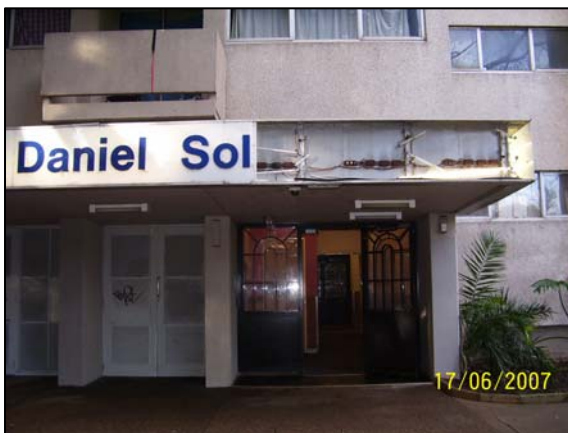
The sign on the front of the Daniel Solander Building is damaged. The sign is in a prominent position above a main entrance to the building from Waterloo Green. The damaged sign overlooks the eastern end of the park and portrays the impression that there is no ownership of the area and building. This encourages illegitimate use, anti social and criminal behaviour.

The sign be repaired or removed completely and the awning fixed.

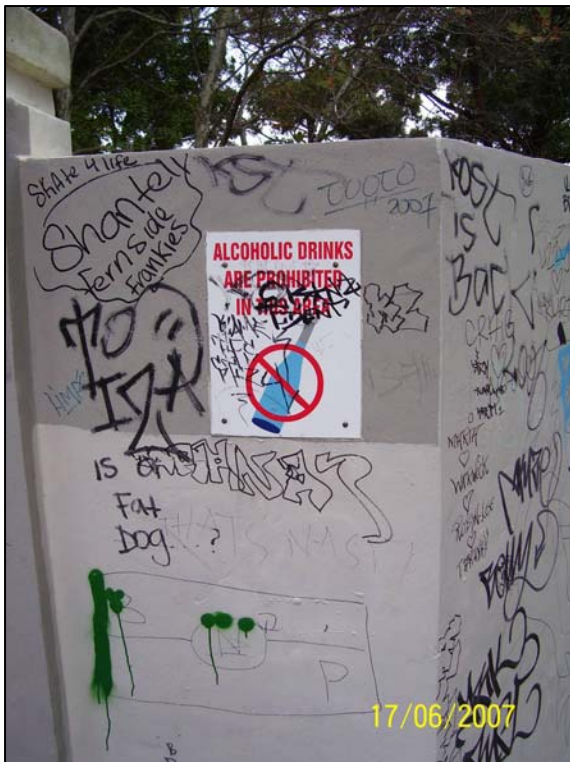
The majority of surfaces in the area were subject to graffiti. The graffiti mostly consisted of profanities and 'tags'. Audit members indicated the graffiti had been in place for months and that the Department of Housing did not have a rapid graffiti removal program or any other approach to control and/or abate this type of vandalism. The amount of graffiti in the audit area indicates there is no ownership of the area. Lack of ownership will increase the illegitimate and criminal behaviour occurring in an area.

The following strategies be adopted with regard to graffiti:

- Graffiti removed within 48 hours.
- Defensive planting in front of walls.
- Use of graffiti resistant colours and coatings.
- Use of tiled and painted murals.

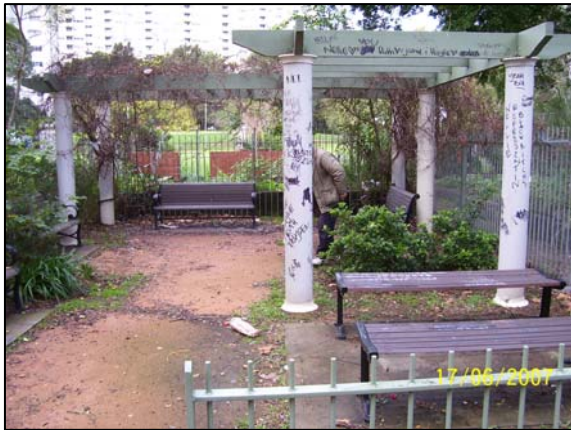
There are two community gardens in the audit area that the audit team indicated are cared for and used by local residents. Although the actual garden beds have been looked after the overall appearance of the gardens was one of disarray.

The community gardens be redesigned using CPTED principles. Consideration should be given to opening up the gardens to create an 'activity generator'. Encouragement should be given to creating a more organised garden feature using defensive planting shrubbery to discourage vandalism.

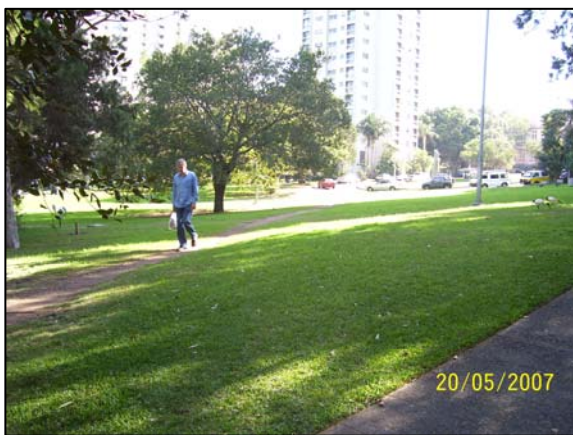
The footpaths in some parts are not wide enough and people do not feel comfortable using them.

Pedestrians feel more comfortable sharing wide paths rather than narrow paths. Three metre wide paths facilitate psychologically comfortable pedestrian traffic in moderately busy areas. Consideration should be given to encouraging greater use of pathways by colour coding pathways, cycle-ways, etc. Well used pathways provide excellent natural surveillance for the area thereby reducing crime and fear (see below examples).

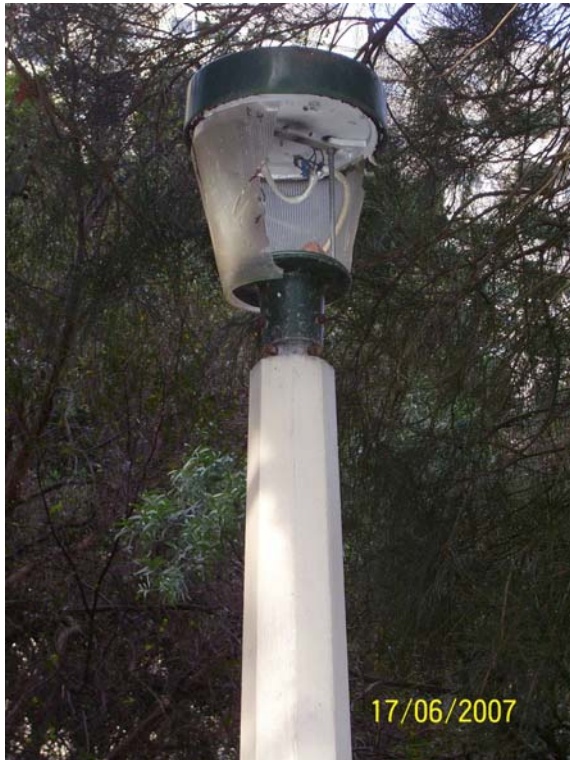
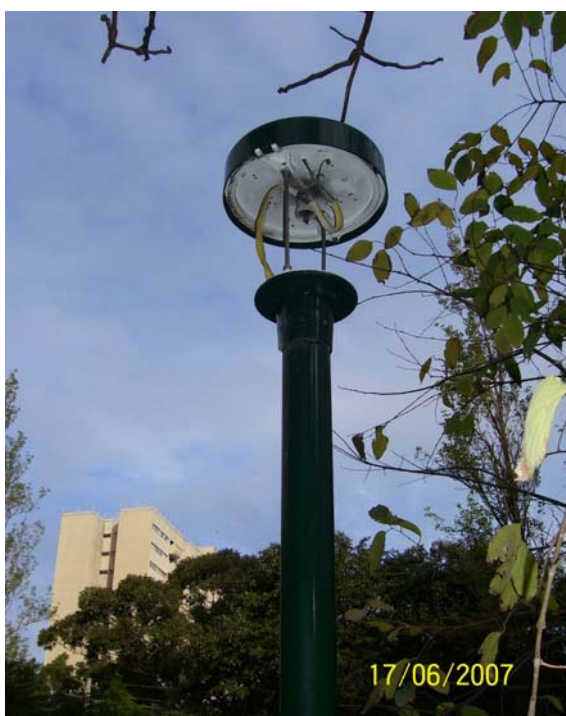
Much of the existing lighting was either physically damaged or not working.

Some landscaping is overgrown and obscures existing lighting in some areas.

- The existing lighting is fixed ASAP.
- A lighting plan established that includes a rapid repair and maintenance program where lights are fixed within a 24-48 hour period.

- Lighting should meet minimum standards. Crime and fear reduction are specified as key objectives in Australian Lighting Standard AS1158. Effective lighting contributes to public safety by reducing fear, increasing the community activity, improving visibility and increasing the chance that offenders will be detected and apprehended.

- It is recommended that special attention is paid to lighting along pedestrian pathways. Lighting should be sufficient so that there is facial recognition at a distance of 15 metres. Areas beside thoroughfares should also be evenly lit to avoid opportunities for concealment.

- The use of 'colour correct' Metal Halide or Mercury Vapour lights is recommended.
- Signs should be lit so that the information can be seen and understood at night.

Vegetation, signs and other structures can diminish the effectiveness of external lighting. Keep lighting clear of shrubbery, tree branches and other structures.

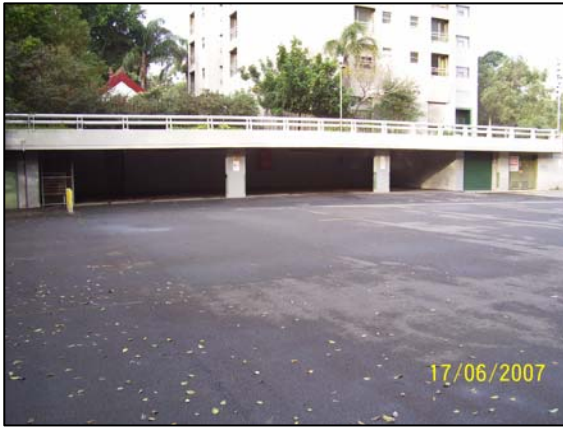
The lighting in the adjoining car parks does not appear to meet minimum lighting standards.

Ensure the outdoor car park lighting meets the minimum standards. Paint the ceiling and vertical structures of the covered car parks white to increase the lux levels and illumination.

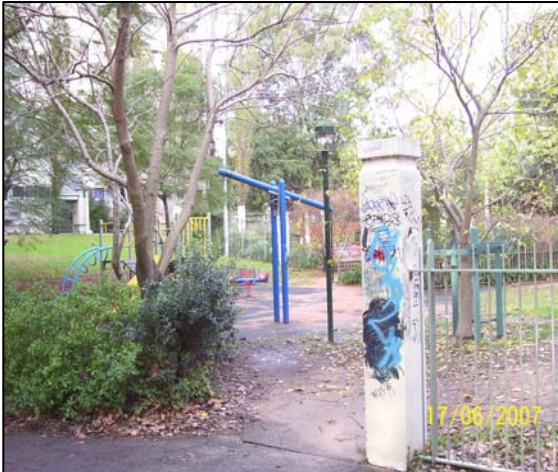
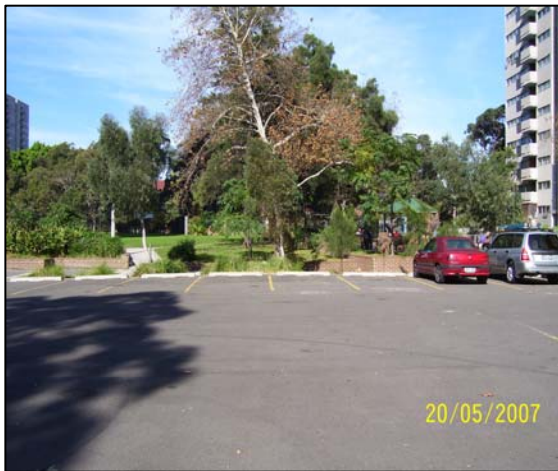
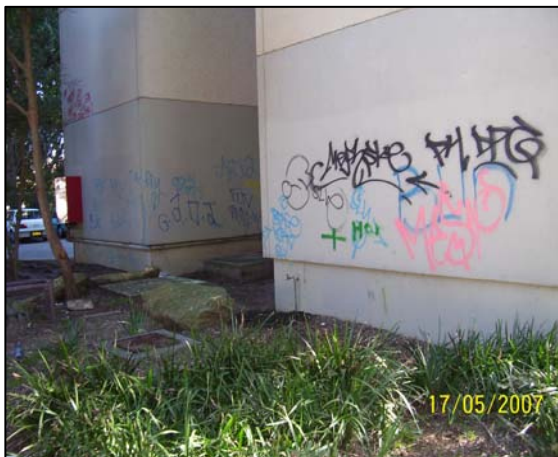
Overgrown and unkept trees and shrubbery are obstructing natural surveillance and sightlines within the park. Trees and shrubs along the Raglan Street border and northern car park border are blocking sightlines and natural surveillance into Waterloo Green from the street.

Easily accessed concealment and entrapment sites located around buildings.

Public gardens can be both attractive and safe. When well kept they can create the impression of ownership and control over the area. Garden plans should strike a balance between ambience and safety. The garden plan should involve a long term maintenance plan to ensure landscaping in regularly trimmed, kept low and clear of sight lines.

Research and strong anecdotal evidence indicates that vegetation is commonly used by criminals for concealment and to create entrapment pockets for their victims. Plants that block sightlines lessen natural surveillance. As a general rule lower tree limbs should be above average head height and a 900mm maximum height applied to shrubs.

The tree and shrub border along Raglan Street should be regularly trimmed to maintain natural surveillance from the street through to the basketball court.

The tree and shrub border along the northern car park should be regularly trimmed to maintain natural surveillance from the car park to the BBQ and playground area.

Uneven building set back and uncontrolled streetscape gaps can attract inappropriate activity. Optically permeable gates and fences can restrict access to potential entrapment sites around buildings.

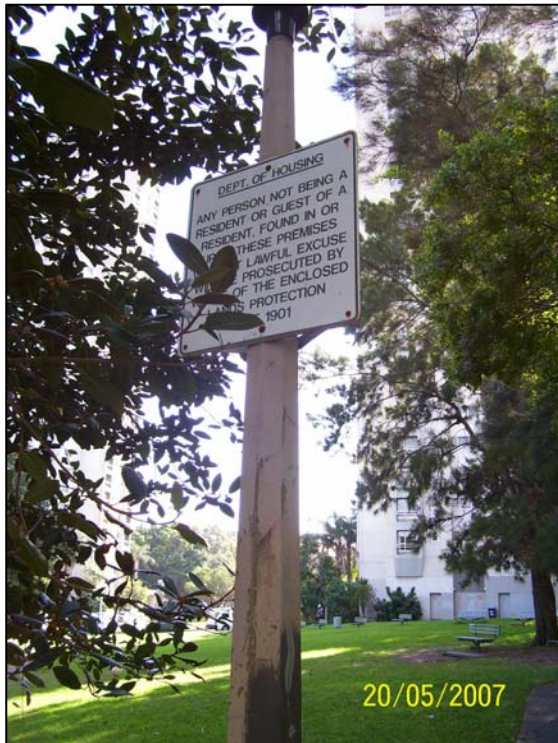
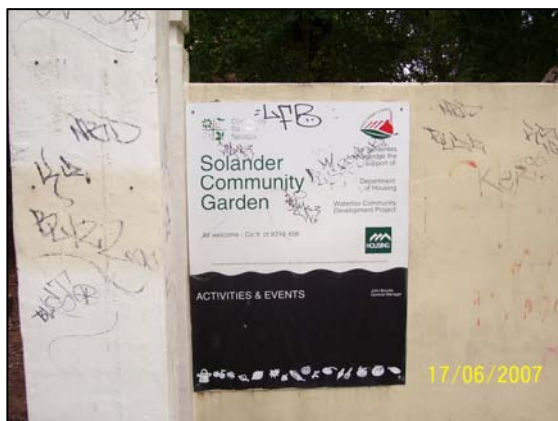
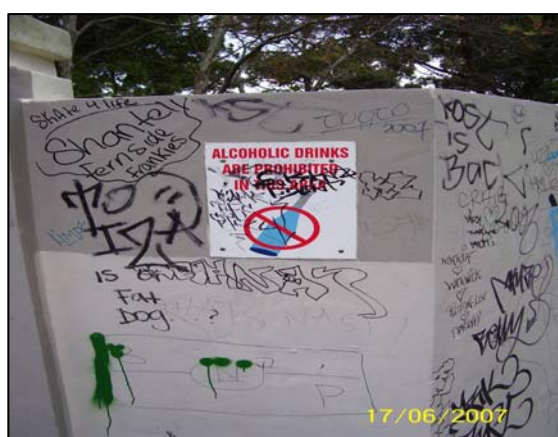
No signage to indicate the name of the area and limited signage displaying the rules governing the use of the park.

The majority of signage in the audit area is vandalised and poorly positioned.

- Clear and concise signage and celebrated entrances should be located at the main access point on Raglan Street and the northern car park. The signage should be lit and include a map of the park identifying the main features. This signage should be large enough and positioned so that it is visible from the street/car park (see example below).
- Clear and concise signage positioned at the eastern and western ends of the park where they can be clearly seen when entering the park from the residential towers.

- All vandalised signage be removed.
- The type, style and positioning of signage reviewed as to its appropriateness and according to CPTED principles.
- A program of regular maintenance to ensure that damaged and vandalised signs are replaced or repaired within a short time frame.

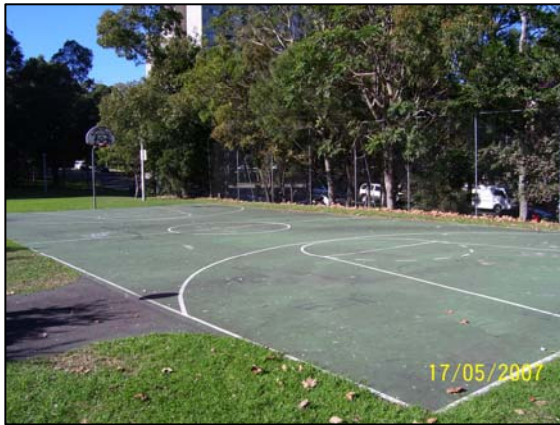
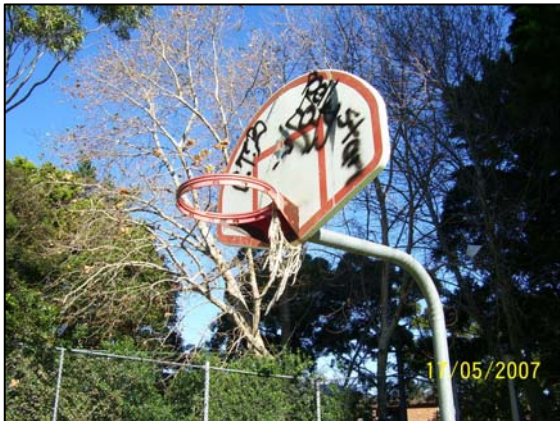
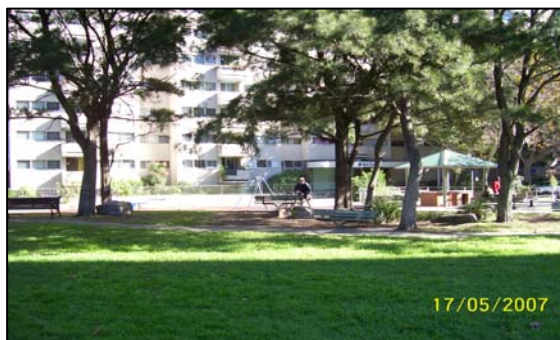
The basketball court is not well maintained and therefore not used properly.

- Youth activity generators are common targets for vandalism, particularly when isolated. The natural surveillance of the area should be maximised by minimising the shrubbery between the basketball court and Raglan Street and maximising the amount of pedestrian traffic with appropriate footpaths.
- A regular maintenance program where the basketball court is regularly checked for vandalism and repaired in a short time period.
- Community and sporting groups should be encouraged to run competitions and coaching clinics on a regular basis.

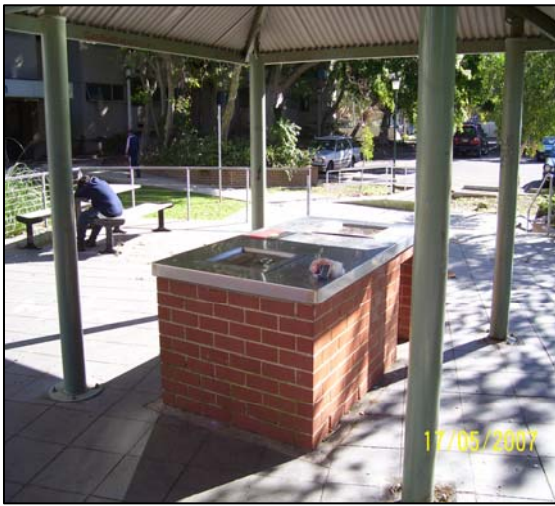
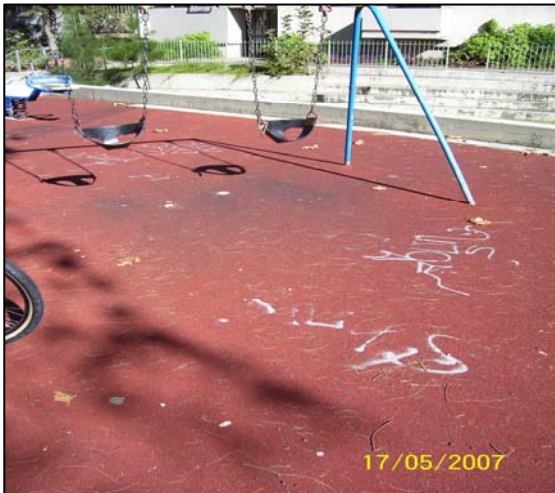
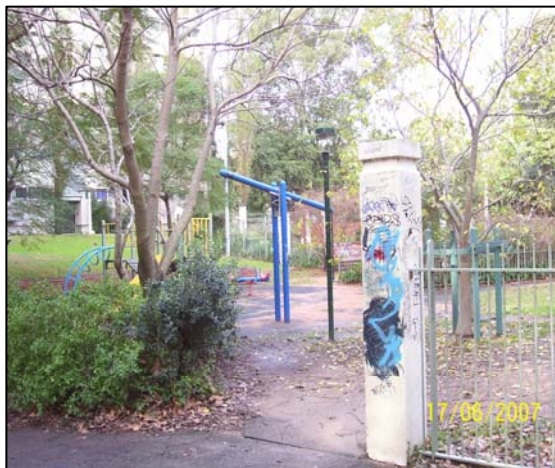
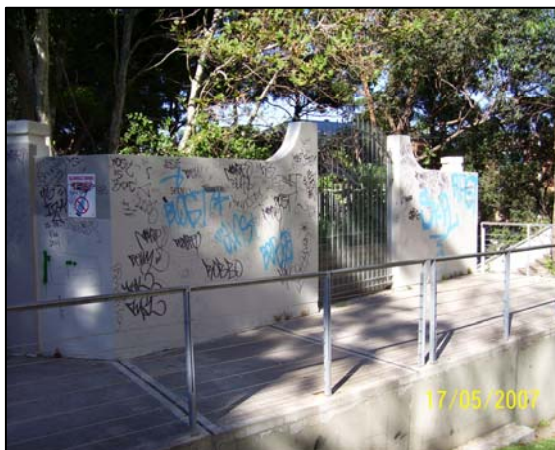
The BBQ facilities is being used by groups who congregate for the purpose of consuming alcohol. This has caused an increase in the fear of crime for residents. The electric BBQ plates have been disabled by the Department of Housing to discourage the use of the BBQ's as heaters by these groups. The BBQ's have been vandalised by graffiti.

The two childrens playground areas are uninviting and unlikely to be used by families because of their poor condition.

The two community garden areas are uninviting, have been vandalised and create an entrapment area.

Outdoor seating is being used for illegitimate purposes such as the consumption of alcohol. Seating is in a poor condition.

Communities with inadequate resources to cope with adult unemployment, boredom, drug and alcohol abuse and other social problems often have to deal with the consequences of these issues. The issue of 'street drinking' is complex and there are a number of solutions that are outside the scope of this report. The issue of 'Street drinking' and should be considered as an issue in

Switching off the BBQ plates has not discouraged the illegitimate use of the BBQ area. It is not clear if the BBQ's were used by legitimate users prior to being disabled, in any case the area currently can not be used for it's designed purpose. Consideration should be given to enabling the BBQ plates, repairing any vandalism and actively encouraging community groups and families into the area to use the facilities.

- All graffiti removed and all damaged equipment repaired or replaced.
- Landscaping in the area around the playgrounds to increase the visual appeal of the area and improve sightlines.
- Install visually permeable security fencing around the perimeter of the playground to increase security and create a control barrier.
- Remove all seating in the immediate area around the playgrounds to minimise paedophile activity.
- Locate bench seating with armrests (to prevent lying and sleeping) inside the playground fencing to maximise parental supervision and discourage paedophile activity.
- Implementation of a regular monitoring and maintenance/repair program.

- All graffiti removed and vandalism repaired.
- Redesign the garden to remove the entrapment areas and create an activity generator that increases pedestrian flow and natural surveillance.
- Actively encourage residents and community groups to use the gardens.
- Remove existing seating and replace with bench seating with armrests.

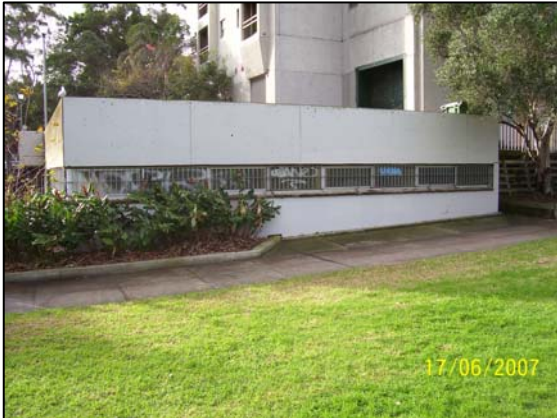
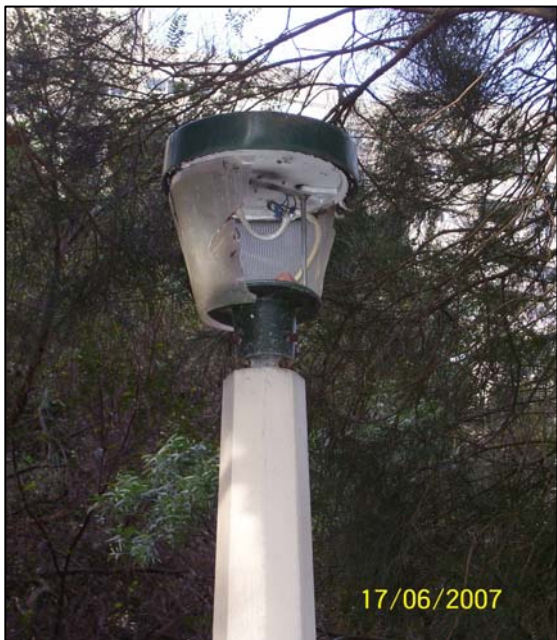
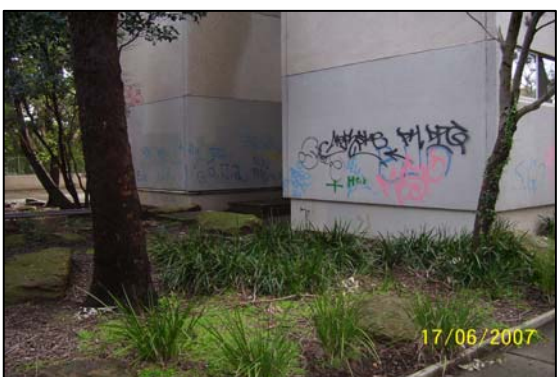
Entire audit area is poorly maintained as detailed throughout the report.

- Clean, well maintained areas often exhibit strong territorial cues. Research shows run down areas negatively impact on perceptions of fear, community confidence, legitimate use of public space and ultimately crime opportunity. Maintenance is a strong indicator of area safety and is recommended a maintenance management plan for the audit area and the surrounding buildings is implemented.

- The maintenance should be carried out on a regular basis to enhance the appearance of the area.
  - Weekly maintenance checks should be undertaken so that repairs can be undertaken promptly without the need for residents to report a problem before it is fixed – there should be a proactive (rather than reactive) approach to maintenance.

- Ideally repairs should be completed within a 24-48 hour period of the damage occurring.
  - The maintenance plan should include the residential buildings adjoining the audit area.

- Vandalism can induce fear and avoidance behaviour in public spaces. The act and outcome of graffiti can reward offenders. The display of one's handywork to others can be a strong motivation to repeat the behaviour. The longer 'tags' are left on display, the greater the reward and repetition will occur. A graffiti management plan is recommended.

- Rapid removal has proven to be a successful long term graffiti management strategy where graffiti is removed within a 24-48 hour period.
  - Graffiti vandals favour permeable building surfaces as 'tags' are more difficult to remove and often a ghost image will remain

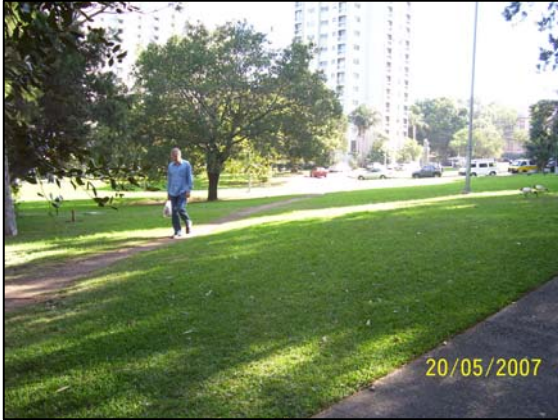
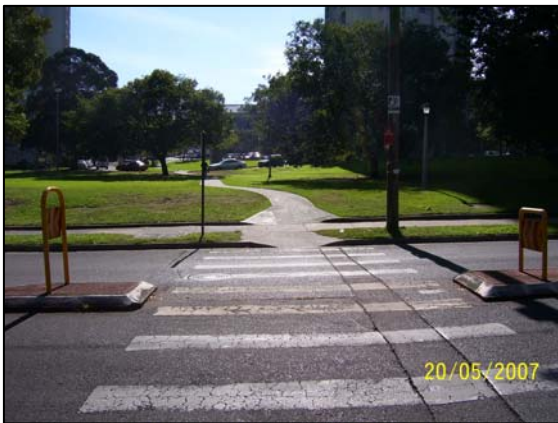
Consumption of alcohol and associated anti-social behaviour in the audit area.

- Inclusion of the Waterloo Green audit area as a part of the taskings for general duties police.
- Annual police–community public relations activity to improve the rapport between police and the Waterloo Green Community. For example; NRMA Crime Prevention Van/Community BBQ
- Targeting of nearby licensed premises by the Redfern LAC Licensing Officer for alcohol related supply offences and a review of hotel trading hours.
- Regular high visibility police operations during peak usage and hotspot times.
