# EVELEIGH RAILWAY YARDS LOCOMOTIVE WORKSHOPS CONSERVATION MANAGEMENT PLAN

ISBN 0 7310 4073 2  
HG REPORT NO: 95/08

HERITAGE GROUP  
STATE PROJECTS  
NSW PUBLIC WORKS

JUNE 1995

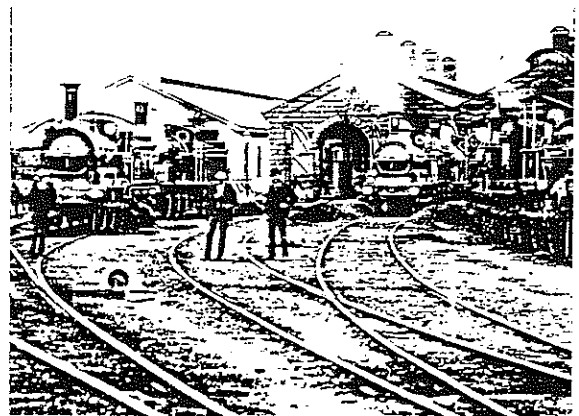
Illustration 1.1: Redfern Terminal Engine Sheds, Early 1870s. The design of these sheds is typical for the type and they are similar to English models, Burke, p.6.

The Redfern Railway Yard (extending from just north of Cleveland Street to Devonshire Street), by 1864, included a workshop and forge, and an engine shed (c. 1855, See Illustration 1), all connected by rail to a circular turntable. The complex also included a carriage shed, goods shed (located adjacent to the temporary shed) and a meat storage shed.

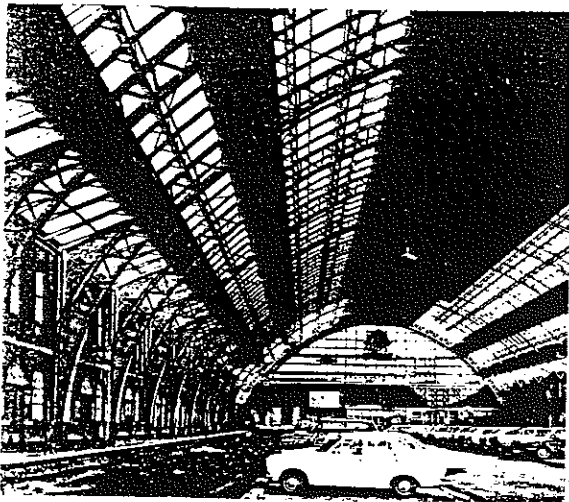
Illustration 1.3: Manchester Central, England 1876. Train Shed designed by Sir John Fowler. This type was represented in Australia by the now demolished Eveleigh Running Sheds, Binney & Pearce, p.46.

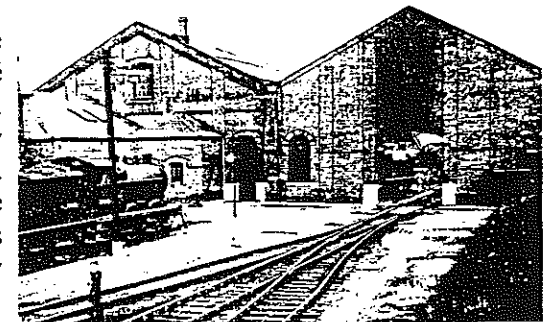
Illustration 1.5: Engine Shed, Hasland, Midland Railway, England, Binney & Pearce, p.169. This is typical of Engine Sheds built in Australia for example, those shown in illustration 1.1.

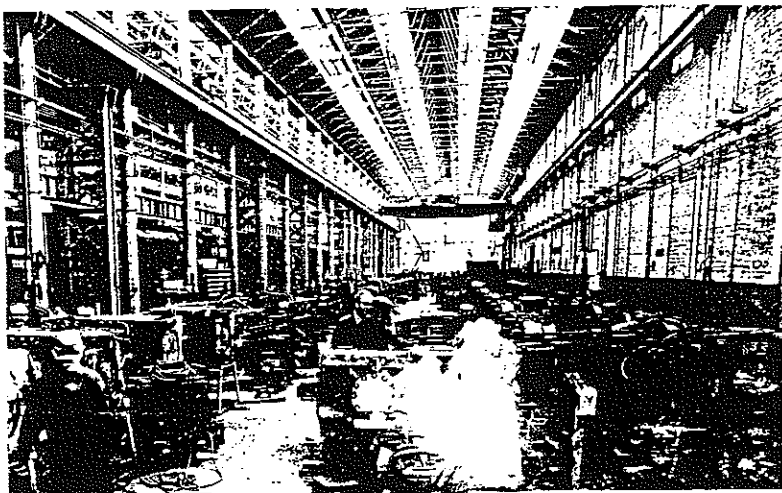
Illustration 1.7: Glasgow Railway Workshops. The double columns, trussed roof, gantry crane, bays and top lit roof are very similar to Eveleigh. (The Glasgow Workshops are believed to be demolished), Binney & Pearce, 170.

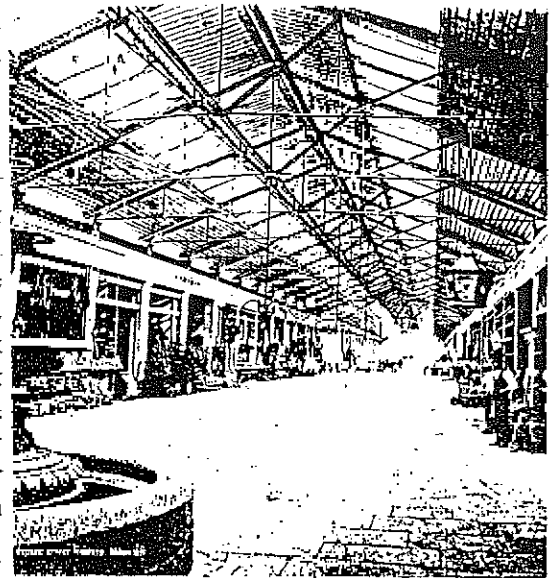
Illustration 1.8: George Street Markets, 1870, was an example of another type of iron building in Australia. It was replaced by the QVB, Sharkey Collection 776, PWD.

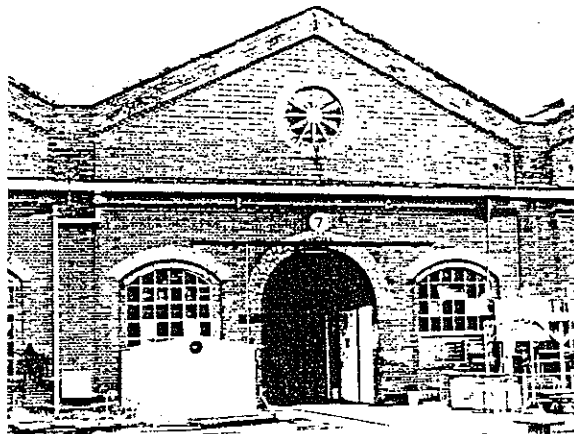
Illustration 1.10: Newport Railway Workshops, Melbourne. The composition of the building is less formal than Eveleigh. At Newport the gable is expressed as a pediment and the windows are semi-circular arches. Generally the buildings are similar with face brickwork divided into bays and forming a parapet, polychrome work around openings, the bulls eye window and the central opening, Doring, Newport.

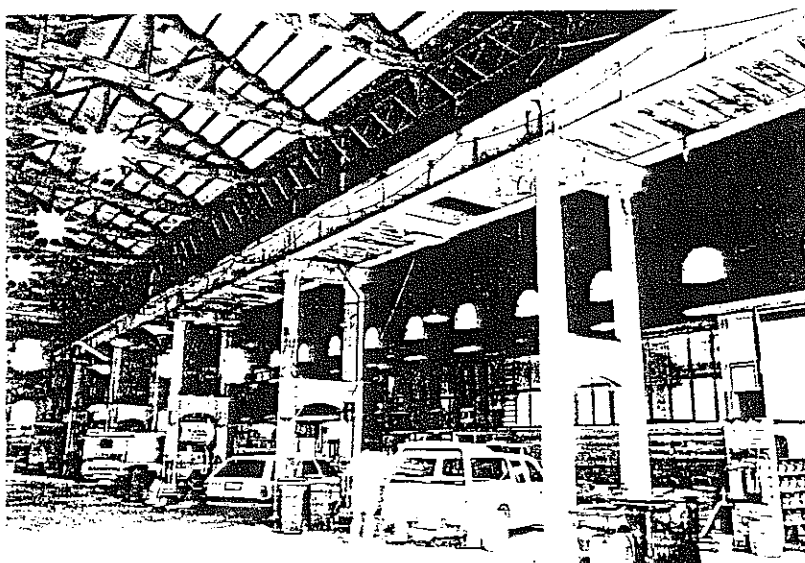
Illustration 1.13: Honeysuckle Point Workshops, NSW, Interior view. Note the double columns and lattice girders, identical to Eveleigh. The roof trusses are timber, Doring, Honeysuckle.

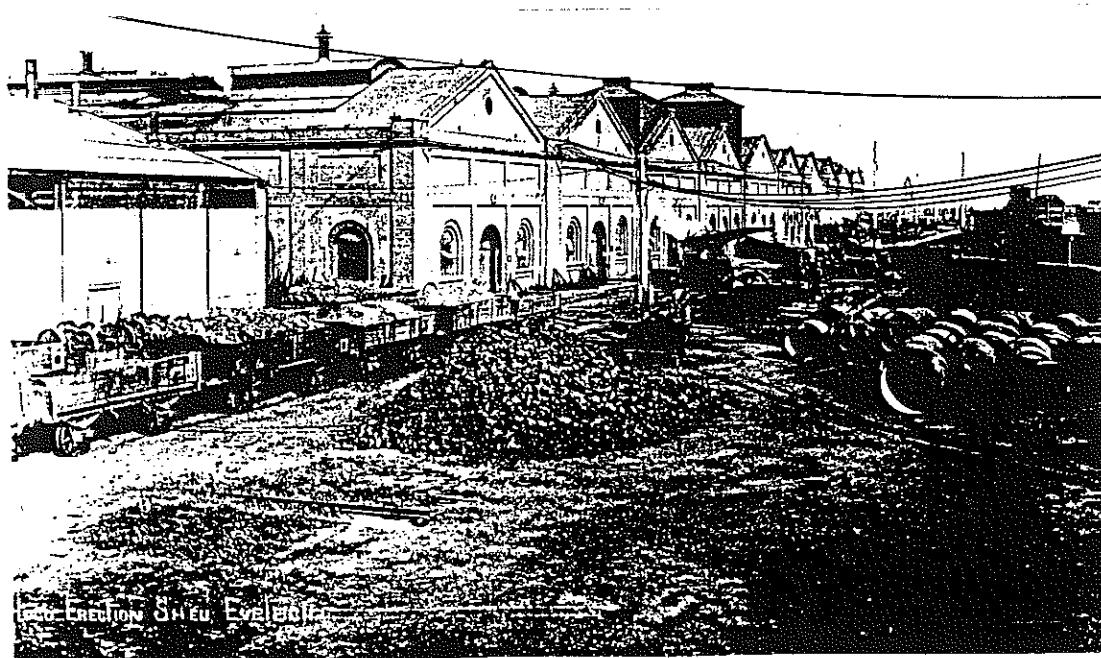
Illustration 1.19: Eveleigh Rail Yard in 1910. The Spring Shop on the left. Note a second tower has been added and Bay 4a has altered, ML GPO Video Disc 1, 12018.

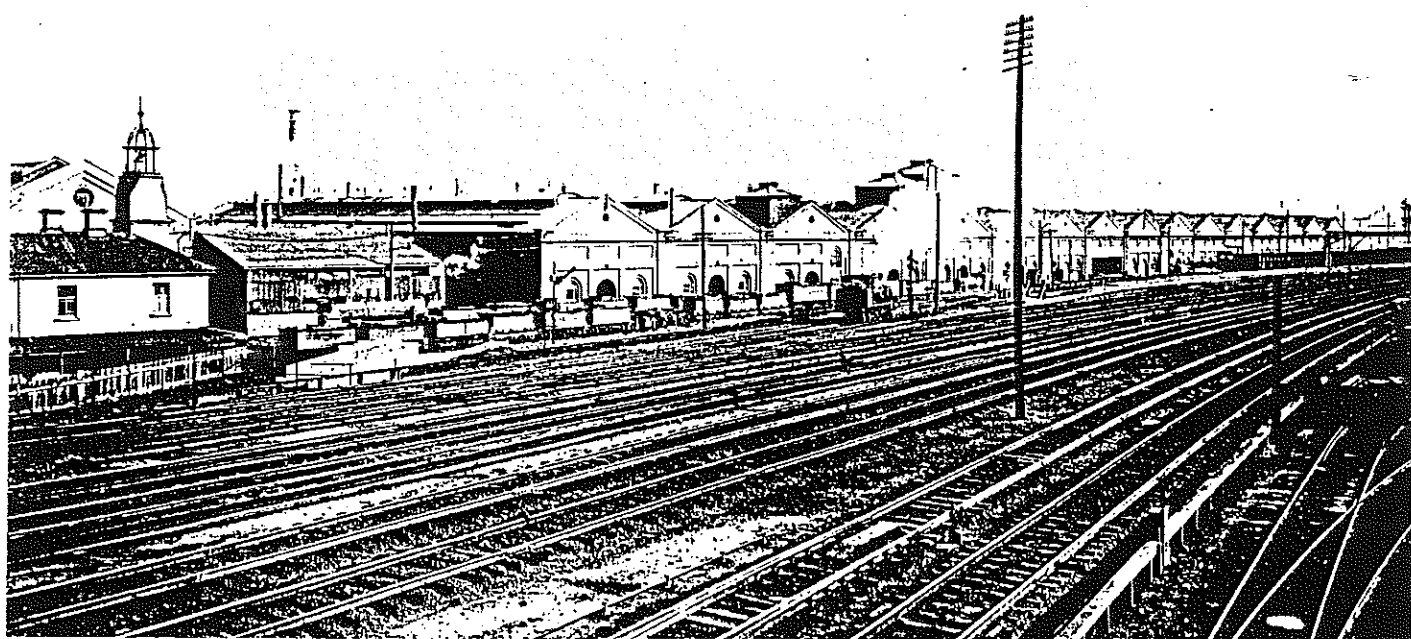
Illustration 1.21: View from Redfern overbridge. Bay 3 has a high level window. Note the chimney stack, the additional tower, which now total three, and the Spring Shop to the north of the Workshops. SRAO ELW 601/41

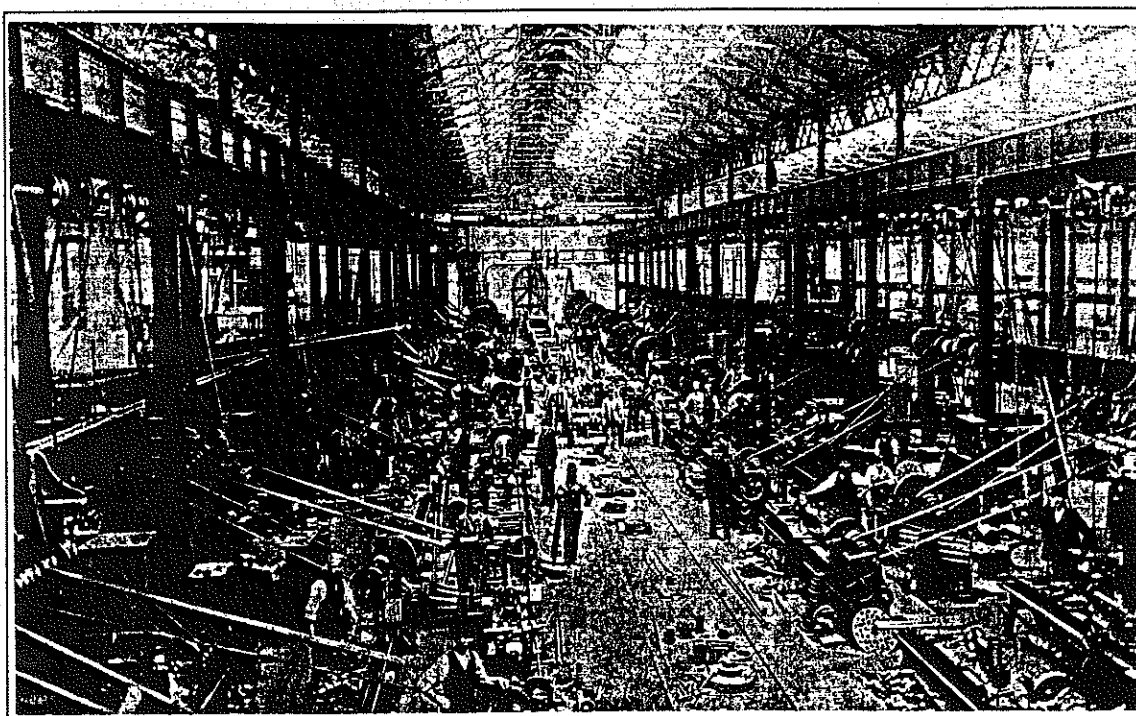
Illustration 1. 28: Wheel Shop, Bay 9 looking south, showing wall engine on back wall l.h.s. The counter shafts are shown suspended under the column headstock with belts driving counter shafts fixed to girders between the columns. Machines were driven by belts directly off the line shaft or off the counter shafts. Note the wheels on the centre road and the overhead travelling crane. SRAO ELW 601/19.

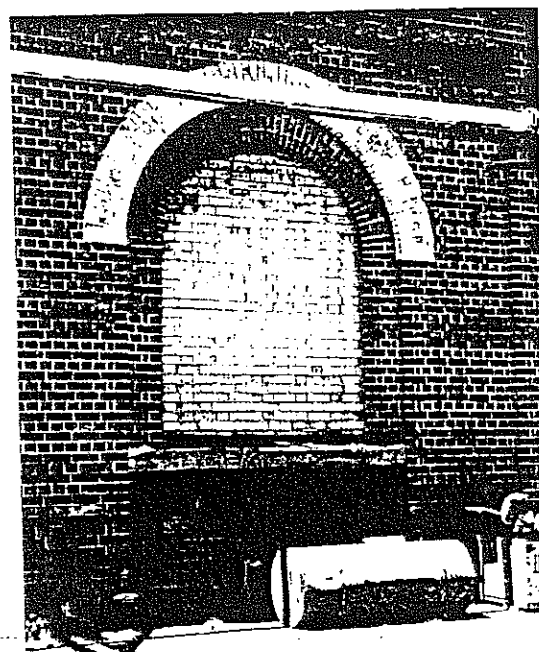
Illustration 2.8: Typical blank arch. Photo Jean Rice, 1995.

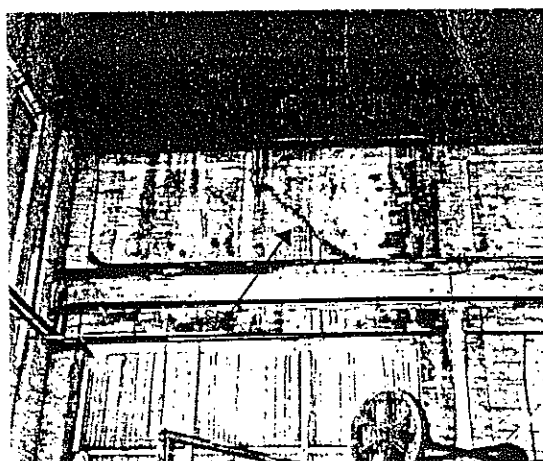
Illustration 2.19: Interior of Bay 1, N-E corner. Note cracking brickwork.

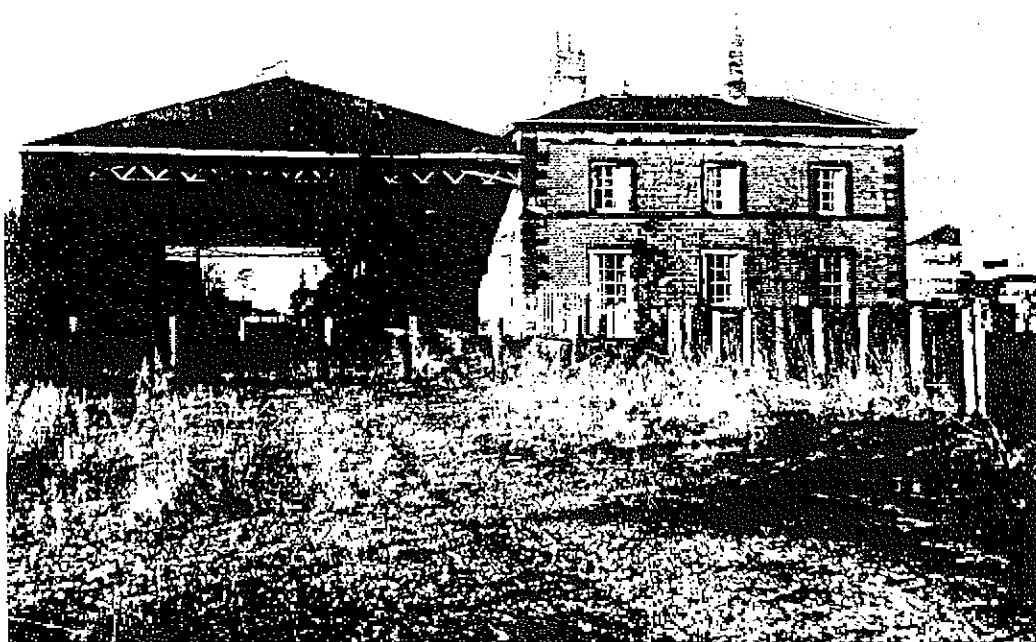
Illustration 5. 1 Pocklington Station at Humberstone, built in 1847, shown after the closure of the rail line. Binney & Pearce, p.220.
