BAY 4 SOUTH

EVELEIGH LOCOMOTIVE WORKSHOPS MACHINERY CONSERVATION 1996 Item Name: Craven Plate Rollers 1886 Item No. 181 Condition: The item is in good/excellent operating condition. Significance Matrix State Historical Themes: Historical Aesthetic Social Technology/ ☐ Moveable Item ☐ Industrial Relic Research Category Potential ☐ 13 Transport Themes X Rare X ☐ 15 Utilities Repres-☐ 16 Industry entative X × ☐ 18 Technology ☐ 20 Government Administration **Statement of Significance** The item was an integral part of the Eveleigh Locomotive Workshops being associated with their operation for over 100 years. The item is an integral part of the Boiler Makers operational group. The item represents former manufacturing technologies now rarely evident in operating workshops. The item evidences the versatility of the workshops in the manufacture of tools and machines. The item has research and education potential for developing an understanding of early engineering practice. The item will yield information on the nature of past work practices. The item exhibits a high degree of structural integrity. **Conservation Policy:** The item is to be retained in its present location and be preserve

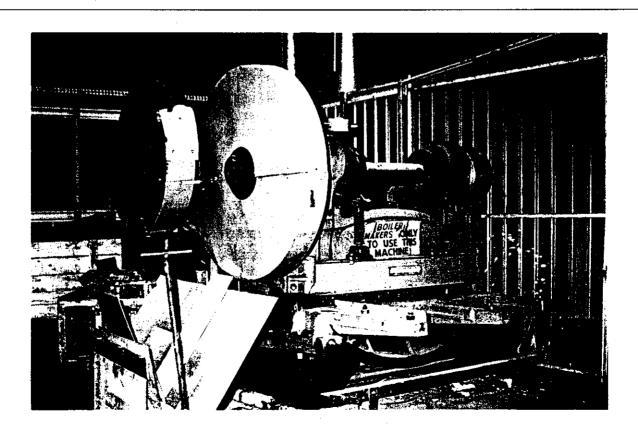
FILM No. 95-169-6-11

Function and Operation: Plate is placed on the plate holders at the front of the machine and placed in precisely the correct location, the machine is then started and the massive cast iron blade supports are brought against the material and it is cut to length.

Item Nar	ne: Ben	nie Metal G	Guillotine				Item No. 182
Condition Very goo		ional condi	ion.				
Significa	ance Ma Historical	trix Aesthetic	Social	Technology/		storical Themes:	
				Research Potential	Category	Moveable Item	☐ Industrial Relic
Rare	M			×	Themes	☐ 13 Transport☐ 15 Utilities	
Repres-	***	\$	П	ĸ		☐ 16 Industry	
entative		M	u	<i>p</i> 4		☐ 18 Technology ☐ 20 Government	Administration

- 					<u> </u>		comotive Workshops
form and	tion and dexhibits	which had a unity in nderstandir	l genera its desigi ig of ear	l engineering n and detail. Iv engineering	applicatior The item har practice.	n. The item is imp as research and ed The item will yield	ng massive cast-iron oressive in size and ducation potential for d information on the m its existing fabric.
Conser	vation P	olicy:		· · · · · ·			
The iter operatio	n is to nal. Not	be retaine e: If requir	d in its ed, the it	present locat em may be re	ion and b moved to f	- F	e item is to remain
Policy I	mpleme	ntation:					
rust is to	be rem	oved or tre	ated. All	ned and degro external surfa stalline wax.	eased usir aces are to	ng appropriate met be treated with an	hods. All superficial appropriate sealant
Conserv	e in situ.	. If required	d, the ite	m may be rem	oved to Ba	ay 2 South.	·
Mainter	nance So	hedule					
Inspect	for physi	cal damage	e and det	erioration eve	ry 12 mont	ths and implement	repair as necessary.

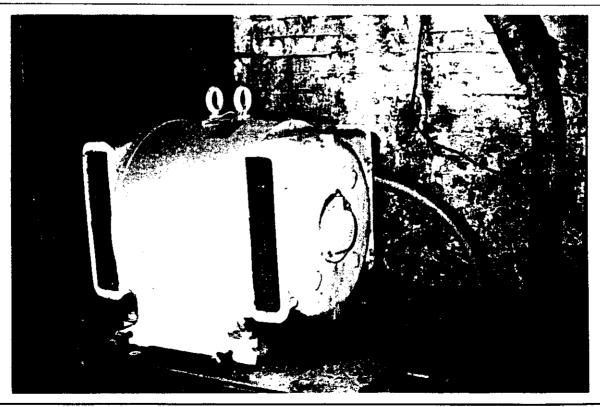
Photo: FILM No. 95-169-6-13 Photographed and inspected December 1995

Description: The Hydraulic System consists of an electric motor connected to the gearbox of a three throw electric pump, a steam hydraulic pump by Fielding and Platt, a water reservoir and two hydraulic accumulators. This 100 horsepower motor is by Hawthorn Davey and Company Ltd of Leeds, England. It is believed that this motor was installed with the three throw pump. However, the base on which it stands indicates that another motor has been used to power the pump at some time in the past.

Function and Operation: The motor operates the pump continuously - but is only on load as hydraulic power is being consumed.

Item Na	me: Hy	draulic Syst	em Elect	ric Motor			Item No. 184
Condition	on:	440	-		· · · · · · · · · · · · · · · · · · ·		
Signific	ance Ma	atrix		 	State His	storical Themes:	
	Historical	Aesthetic	Social	Technology/ Research Potential	Category	☐ Moveable Item	☐ Industrial Relic
Rare	X			S	Themes	13 Transport	
Repres-						15 Utilities	ļ
entative	X			X		☐ 16 Industry ☐ 18 Technology	
						20 Government	Administration
Stateme	ent of Si	gnificance	The ite	m was an inte	egral part o		omotive Workshops
1		-				•	part of the hydraulic

-				•	•	_	The item exhibits a
nigh deg	ree of st	ructural inte	egrity. Th	ne item is an ii	ntegral par	t of the hydraulic p	ump assemblage.
				•			
Conser	vation P	olicy:

-		•	eserved as part of which it belongs.	the hydraulic pump
The item	is to be	reconnecte	ed to its p	ower source a	and made	operational.	
Policy I	mpleme	ntation:

•	•			_1			
i ne mot	or snould	a be inspect	ted by an	electrical cor	iservator a	nd retained as nec	essary.
Conserv	e in situ.						
				•			
Mainten	ance Sc	hedule

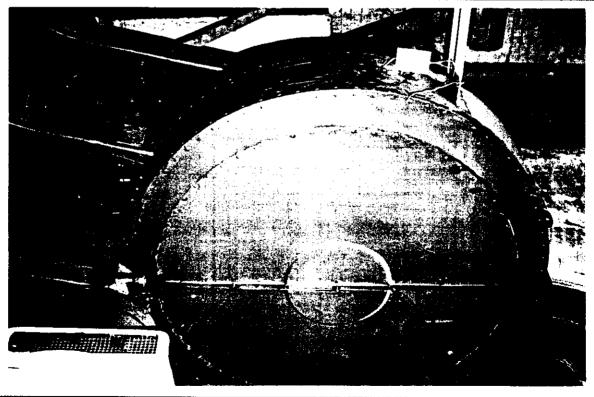
Photo: FILM No. 95-169-6-14

Description: The Hydraulic System consists of an electric motor connected to the gearbox of a three throw electric pump, a steam hydraulic pump by Fielding and Platt, a water reservoir and two hydraulic accumulators. This is a vertical triplex, single acting pressure pump driven by a 100 horsepower electric motor via a very large reduction gear. The pump was installed in this location in 1914 and is by Hawthorn Davey and Company Limited of Leeds, England. The pump is mounted on a cast iron footing which also holds the platform on which the motor is mounted.

Function and Operation: When the workshops were in full swing the pump was switched on for each shift. The pump rotated continuously but was not placed under pressure unless hydraulic fluid was being sent through the system.

Item Nar	ne: Hydr	aulic Syste	m Pump)			Item No. 185
Conditio	n:	- · .					
		m appears d, serviced			dition provi	ding power sources are	e connected and
Significa	ance Mat	riy		<u> </u>	State His	storical Themes:	
. •	Historical	Aesthetic	Social	Technology/ Research Potential	Category		indust ri al Relic
Rare				図	Themes	☐ 13 Transport☐ 15 Utilities	ı.
Repres- entative	M			Ճ		☐ 16 Industry☐ 18 Technology	
						20 Government Adm	inistration
its opera	ation is e Il integrity	easy to int	erpret fr n is an ir	om its existi itegral part of	ng fabric.	in its design and deta The item exhibits a ulic pump assemblage	high degree of
Conser	ation Po	licy:					
				sent location which it belor		eserved as part of the	hydraulic pump
The item	is to be	reconnecte	d to its p	ower source	and made	operational.	
1	mplemen						
internal to be cle treated. fluid or p	bare meta eaned an All exter polycrysta	al surfaces d degrease rnal surface alline wax.	are to bed using es are to All pipe	ne dried and good appropriate of the treated to	greased to methods. A with an applisconnecte	d, all bearings and glar prevent rust. All exter All superficial rust is to propriate sealant such d, cleaned, dried and	rnal surfaces are be removed or as Shell ENSIS

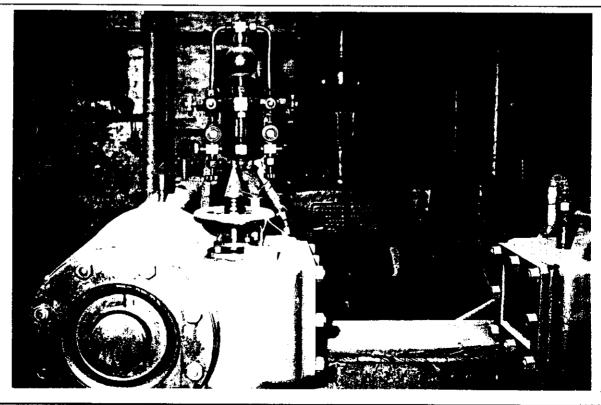
Photo: FILM No. 95-169-6-15 Photographed as

Description: This is a two-cylinder horizontal steam engine direct linked with a two-cylinder pressure pump manufactured in England, about 1885. The two reciprocating pump cylinders are each driven directly by steam cylinders by sharing a common piston shaft and are mounted behind and in line with each steam cylinder. The con-rods to the two metre diameter fly wheel are joined to the centre of each cylinder/pump/piston. Over speed regulation is by a governor driven from the fly wheel crank shaft.

Function and Operation: The pump is connected to the Number 4 steam boiler and when it was in operation the valving system was actuated by the rise and fall of the accumulators.

Item Nar	ne: Hyd	raulic Syste	m Stear	n Hydraulic P	ump		Item No. 186
Conditio	n:	ts., ·					
In genera the item	al, the ite is cleane	m appears d, serviced	to be in and test	operable cond ted.	dition provi	ding power sources are	e connected and
Significa	ance Ma	trix			State His	storical Themes:	,
	Historical	Aesthetic	Social	Technology/ Research Potential	Category		Industrial Relic
Rare	M	×		M	Themes	☐ 13 Transport☐ 15 Utilities	
Repres-	5	_				16 Industry	
entative	×		u	به		18 Technology	*
						20 Government Adm	inistration
Stateme	ent of Sig	gnificance	u, .u.				
its opera	ation is al integrit	easy to int	erpret fi n is an ir	rom its existi ntegral part of	ng fabric.	in its design and deta The item exhibits a ulic pump assemblage	high degree of
Conser	vation P	olicy:					
The iten	n is to be lage and	e retained i hydraulic s	n its pre ystem to	sent location which it belor	and be prongs.	eserved as part of the	hydraulic pump

The item	is to be	reconnecte	ed to its p	ower source	and made	operational.	
Policy I	mpleme	ntation:		· .			
internal to be cle treated. fluid or	bare me eaned ar All exte polycryst	tal surfaces nd degrease ernal surfac alline wax.	are to to to ed using es are to All pipe	oe dried and one de	greased to methods. with an app isconnecte	d, all bearings and glar prevent rust. All exter All superficial rust is to propriate sealant such ed, cleaned, dried and	nal surfaces are be removed or as Shell ENSIS
Mainter	nance Sc	hedule		- Lipu	·		
		nal surfaces on section.	for rust	every 12 mor	nths. Whe	re necessary, coat as	recommended in
						Any rust or oxidation or and sealant.	product must be
Interpre	etation:

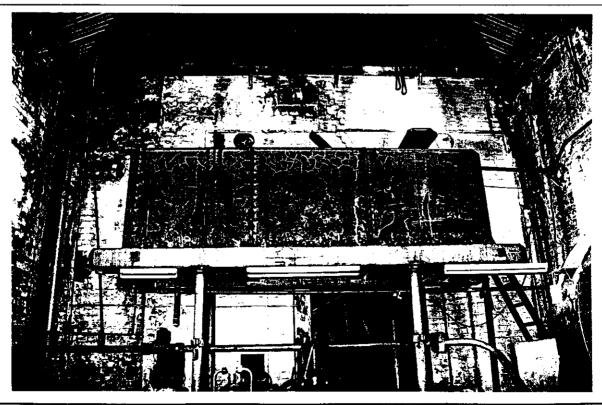
Photo: FILM No.

Item Name: Hydraulic System Overhead Reservoir Item No.	187
Name Plate:	-
Associated Items:	
Individual	
Assemblage	
System Hydraulic 49, 52, 144, 152-154, 158, 184-187, 193, 194, 213	
Collection	
Description: This hydraulic reservoir was installed in 1886 to hold the water for the hydr	
system. This hydraulic system exhausted waste and there appears to have been no return pipe	es.
11: A Installation this to estimate 4000	
History: Installed in this location in 1886.	
Function and Operation: The reservoir was filled with Location: Bay 3 South 15 West	
water which gave a low-pressure supply to the high	٦,
pressure pumps.	2
ĺ	3 4
	5
	7
	8 9
	10
├ -	. 11
	13
│ ├ ── ├ ── ├ ──	. 14 15
4A 4 3 2 1

Item Na	me: Hyd	Iraulic Sys	tem Over	head Reservo	oir		Item No. 187		
Condition	on:								
The item	is in god	od/exceller	nt operati	ng condition.					
Signific					State His	storical Themes:			
	Historical	Aesthetic	Social	Technology/ Research Potential	Category	☐ Moveable Item	☐ Industrial Relic		
Rare					Themes	13 Transport			
Repres-						☐ 15 Utilities ☐ 16 Industry			
entative						☐ 18 Technology			
						20 Government	Administration		
potential	for deve	loping an	understar	nding of early	engineerin		earch and education em and its operation ructural integrity.		
Conserv	ation Po	olicy:			 .

-	•	being cleane nedules given	•	d and maintained	d according to the		
Policy Ir	nplemen	itation:			- All The Control of				
superfici	al rust is	to be remo	oved or tr		ernal and e	external surfaces a	opriate methods. All re to be treated with		
Mainten	ance Sc	hedule							
		al and ext the implen			t every 12	months. Where	necessary, coat as		
				٠.			-		
Interpre	tation:				<u> </u>				
		÷							
							i

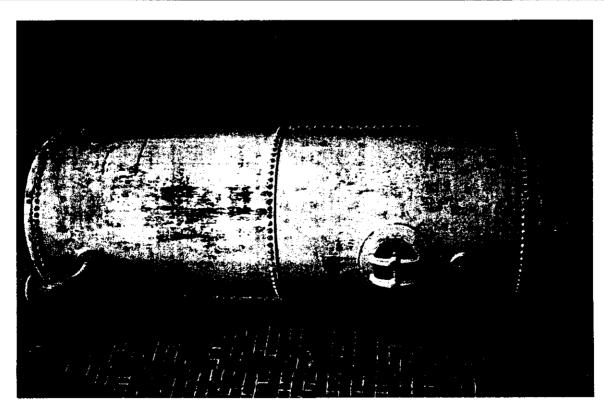
Item Name: P	ressure Vessel	- A-10		Item No. 192
Name Plate: 1	N/A			
Associated Ite	ems:			
Individual				
Assemblage				
System				
Collection				
Description: connected to the	This is located outside ne air compressors in the	_		pressure vessel
History: Unkn	own.			
Function and	Operation: N/A		Location: Bay 4 Sou	th South of Bay
				1
				2 3
				6
				á
				9
				11
			├ ╼ ╼╌┼╌ ┞ ╌┆	12 13
			V	14
			4A 4 3×	2 +1
Photo:	FILM No. 95-169-6-21	Photographed	and inspected Decen	nber 1995
		a.a.

Item Na	me: Pre	ssure Vess	el	<u></u>			Item No. 192
Condition	on:		U 1144				
Cinnifia	11-	A					
Signific	ance Ma Historical	TFIX Aesthetic	Social	Technology/		storical Themes:	
Bana				Research Potential	Category		Industrial Relic
Rare		u			Themes	☐ 13 Transport☐ 15 Utilities	
Repres- entative				Ø		16 Industry	
						☐ 18 Technology☐ 20 Government Adm	inistration
being as	sociated	with their	operati	on for over 5	0 years.	f the Eveleigh Locomo The item is an inte interpret from its exist	gral part of the
Conserv	ation Po	olicy:					
The item	is to be	retained in the second	n its pres	sent location a	and be pre	served as part of the	compressed air
If the iter it to som outdoor	e extent	e displayed from the e	external lements	ly, a suitably o The item is	designed c to be con	over must be erected of served using appropri	over it to protect ate methods for
Policy In	nplemen	tation:					
The item Conserve		be cleane	ed. All	unsound pain	t removed	l and the item shoul	d be repainted.

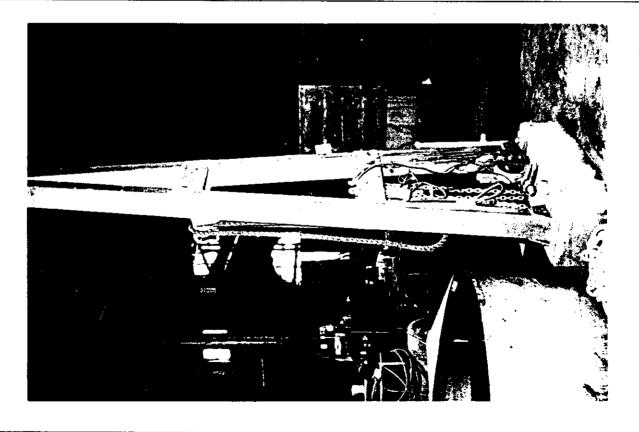
Item Name: Jib-Cra	ne	Item No.	195
Name Plate: N/A			
Associated Items: Individual Assemblage Collection System	☐ ☐ ☐ ☐ ☐ ☐ ☐ ☐ ☐ ☐ ☐ ☐ ☐ ☐ ☐ ☐ ☐ ☐ ☐	95	
Operational Groups			
Description: This si	mall Jib-Crane was used as part of the spring heat treating proc	ess.	
History: Its history is	s unknown but it is believed to be of relatively modern origin.		
	ation: The Jib was swung by hand lly block and tackle hoist was used to quipment. Location: Bay 3 South	11 East 1 2 3 4 5 6 7 8 9 10 11 12 13 14 15 15	
Photo: FILM I	No. 95-169-6-24 Photographed and inspected Decemb	er 1995

Item Na	me: Jib (Crane					Item No. 195
Conditio	on:					· · · · · · · · · · · · · · · · · · ·	
The item	is in god	od structur	al repair	and has no ob	vious signs	s of rust.	
	ance Mai	trix Aesthetic	Social	Technology/	State His	storical Themes:	
	i ii storicai	Aesuleut	Social	Research Potential	Category	☐ Moveable Item	☐ Industrial Relic
Rare					Themes	13 Transport	
Repres-	_	_	_			☐ 15 Utilities ☐ 16 Industry	
entative	x			X		☐ 18 Technology	
						20 Government	Administration comotive Workshops
The item	and its		is easy				ijb crane collection. item exhibits a high
Conserv	ation Po	olicy:					
		ained in its which it b		location and b	e preserve	ed as part of the for	rge assemblage and
Policy Implementation:							
All external surfaces are to be cleaned and degreased using appropriate methods. All superficial rust is to be removed or treated. All external surfaces are to be treated with an appropriate sealant such as Shell ENSIS fluid or polycrystalline wax.

Conserve in situ.							
Mainten	ance Sch	nedule					
Inspect for physical damage and deterioration every 12 months and implement repair as necessary.							
inspect all external surfaces for rust every 5 years. Where necessary, treat as recommended in the implementation section.							
Interpretation:

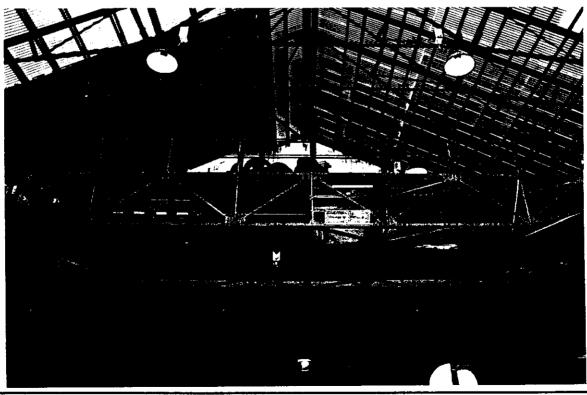
FILM No.

item Na	me: Ove	rhead Cra	ne				Item No. 196
Conditi	on: In a	eneral the	item on	noom to be in	anarabla		
connect	Condition: In general, the item appears to be in operable condition providing power sources are connected and the item is cleaned, serviced and tested. The external surface of the item has						
patches	of superf	icial rust a	nd bare r	netal.	. 100104.	THE EXTERNAL SUM	acc of the item has
Signific	ance Ma	feiv	<u> </u>		04-4-11	4 • • •	· · · · · · · · · · · · · · · · · · ·
	Historical	Aesthetic	Social	Technology/	State His	storical Themes:	
				Research Potential	Category	☐ Moveable Item	☐ Industrial Relic
Rare	×	×		X	Themes	☐ 13 Transport	
Repres-						15 Utilities	
entative	X					16 Industry	
						☐ 18 Technology ☐ 20 Government /	A alau ininanai
Ctata	-4 -6 0		T ()/				
being 29	sur or 916 Pateious	mith their	: I ne ite	m was an inte	grai part o	of the Eveleigh Loc	omotive Workshops al part of the Spring

•	
Policy Implementation:							
All exten	All external surfaces are to be cleaned and degreased using appropriate methods. All superficial						
rust is to be removed or treated. All external surfaces are to be treated with an appropriate sealant							
such as Shell ENSIS fluid or polycrystalline wax. All moving parts of electric motors are to be							
covered	to preven	t ingress o	of dust. C	onserve. May	repositior	in same bay.	
Maintan	5-4						
wainten	ance Sch	ieauie					
Inspect a	all externa	al surfaces	for rust e	everv 12 mont	hs. Where	e necessary coat a	as recommended in
the imple	mentatio	n section.				, noodooda, y, doda t	20 1000111110.1000 117

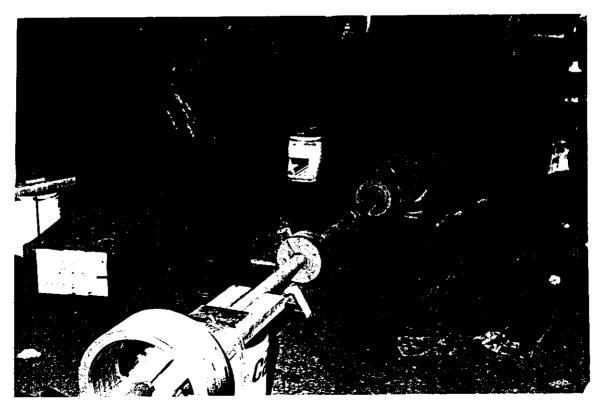
Item Name: Lime Shafting	Item No. 204A
Name Plate: N/A	
Associated Items:	
Individual	
Assemblage 📮	
Collections	
Systems	
Operational Groups	
Description: The two long lime shafts were remove	ed from the locksmiths shop at the extre
north-east of the locomotive workshops site. The otl	ther shorter shafts were used to power sn
lathes in Bay 10. The longer shafts have driving wh	heels or pulleys which are made from tim
while the smaller shafts have steel wheels. The bearing	ing blocks on which the shafts were moun
are also located close by.	
History: The history of the items is unknown, however	er, they were in use prior to 1939.
Function and Operation: N/A	Location: Bay 3 North 6 West
	1
	4 5
	7 8
	9
	10
	13
	15
	4A 4 3 2 1
Photo: FILM No. No Number Photogra	aphed and inspected December 1995

Item Name: Line Shafting/ Line Shafting & Countershafts							Item No.204a-d	
Condition:								
In general, the item appears to be in operable condition providing power sources are connected and the item is cleaned, serviced and tested.								
The external surface of the item has patches of superficial rust and bare metal.								
_	ance Mati Historical	rix Aesthetic	Social	Technology/ Research Potential	State His	storical Themes: Moveable Item	☐ Industrial Relic	
Rare	E			E E	Themes	☐ 13 Transport☐ 15 Utilities		
Repres- entative	E			.		☐ 16 Industry ☐ 18 Technology		
						20 Government A		
Statement of Significance: The item was an integral part of the Eveleigh Locomotive Workshops being associated with their operation for over 50 years. The item evidences the versatility of the workshops in the manufacture of tools and machines. The item and its operation is easy to interpret from its existing fabric. The item exhibits a high degree of structural integrity. Conservation Policy:

The item is to be removed to Bay 13 North and fastened to a wall and be displayed in conjucntion with machines formerly driven by belt.								
Policy Implementation: All external surfaces are to be cleaned and degreased using appropriate methods. All superficial rust is to be removed or treated. All external surfaces are to be treated with an appropriate sealant such as Shell ENSIS fluid or polycrystalline wax.								
Maintenance Schedule								
Inspect all external surfaces for rust every 12 months. Where necessary, coat as recommended in the implementation section.								
Interpretation:
