BAY 4 NORTH

EVELEIGH LOCOMOTIVE WORKSHOPS MACHINERY CONSERVATION 1996 Item Name: Hydraulic Press Item No. 213 Condition: In general, the item appears to be in operable condition providing power sources are connected and the item is cleaned, serviced and tested. The external surface of the item has patches of superficial rust and bare metal. Significance Matrix State Historical Themes: Historical Aesthetic Social Technology/ ☐ Moveable Item ☐ Industrial Relic Research Category Potential ☐ 13 Transport 図 **Themes** X ¥ Rare ☐ 15 Utilities Repres-16 Industry entative ☐ 18 Technology ☐ 20 Government Administration Statement of Significance The item was an integral part of the Eveleigh Locomotive Workshops being associated with their operation for over 50 years. The item evidences the versatility of the workshops in the manufacture of tools and machines. The item and its operation is easy to interpret from its existing fabric. The item exhibits a high degree of structural integrity. **Conservation Policy:** The item is to be removed to Bay 10N. **Policy Implementation:** The machine is to be stripped, all cylinders cleaned and dried, all bearings and glands repacked, all internal bare

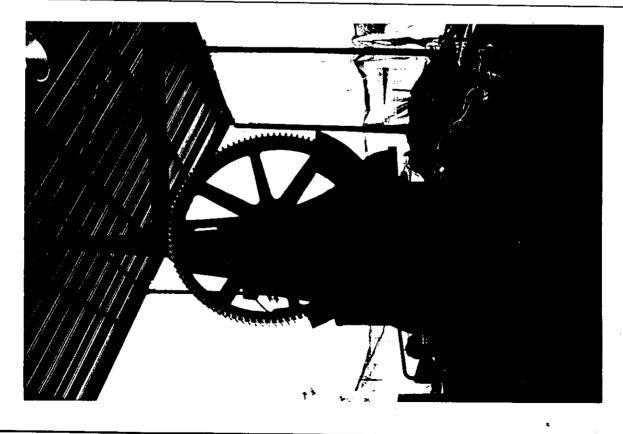
Photo: FILM No.

Description: The De Burgue Electric Shears are massive cast-iron framed shears which operate at low speed. The item is driven by a small electric motor through a gear box and a very large driving gear which is meshed with the cam shaft of the shears. The item is equipped with its own Jib Crane and has its own jig for determining the length of the material to be cut. The shears can cut metal in excess of 50mm sections.

Item Na	me: De	Burgue Ele	ectric She	ars		· · · · · · · · · · · · · · · · · · ·	Item No. 206			
Condition	on:		·							
In gener the item	In general, the item appears to be in operable condition providing power sources are connected and the item is cleaned, serviced and tested.									
The exte	ernal surf	ace of the	item has	patches of su	perficial rus	st and bare metal.				
Signific	ance Ma	trix		•	State His	storical Themes:	 			
g	Historical	Aesthetic	Social	Technology/ Research Potential	Category	☐ Moveable Item	☐ Industrial Relic			
Rare	Ø	Ø		Ø	Themes	☐ 13 Transport				
Repres-						15 Utilities				
entative	Ø			Ø		16 Industry				
on and vo	12.4	_	_	6.		18 Technology

Mainten	ance Scl	hedule:			· · · · · · · · · · · · · · · · · · ·	· · · · · · · · · · · · · · · · · · ·				
Inspect all external surfaces for rust every 12 months. Where necessary, coat as recommended in the implementation section. Every 5 years internal surfaces should be inspected for rust. Any rust or oxidation product must be treated suitably by being removed and coated with an inhibitor and sealant. Inspect for physical damage and deterioration every 12 months and implement repair as necessary.										
Interpret	tation:

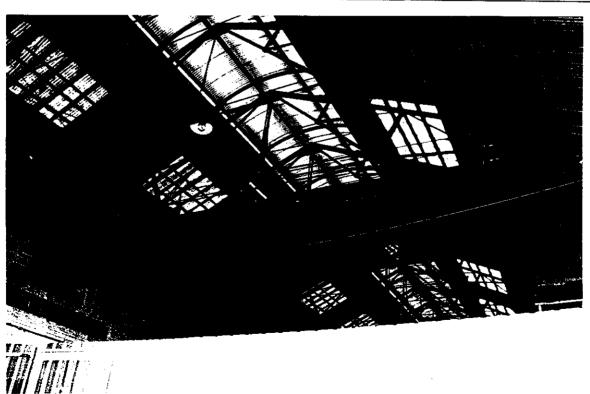
Photo: FILM No. No Number Photographed and inspected December 1995

Description: This crane consists of twin plate girder beams which taper towards the end. It was made by Craven Brothers and was probably located in another bay within the workshops. It would appear that the crane was originally driven by continuous rope, powered by a steam engine at one end of the workshop and later converted to electric power. This crane was mounted in this position, probably in 1926 and was dedicated to the operation of the Davy Press. The crane rail beams on the eastern and western side have been attached to new columns formed from high universal section steel.

Item Na	Item Name: Overhead Electric Travelling Crane Item No. 207								
Condition: In general, the item appears to be in operable condition providing power sources are connected and the item is cleaned, serviced and tested. The external surface of the item has patches of superficial rust and bare metal.									
Significa	ance Mat	rix			State His	storical Themes:			
_	Historical	Aesthetic	Social	Technology/ Research Potential	Category	☐ Moveable Item	☐ Industrial Relic		
Rare	選	×		×	Themes	☐ 13 Transport ☐ 15 Utilities			
Repres-						16 Industry			
entative	×					☐ 18 Technology			
						20 Government A	dministration		
			9 21 1:		L				
assemble The iter engineer exhibits: Conserv Davy asset to its poor	Statement of Significance: The item was an integral part of the Eveleigh Locomotive Workshops being associated with their operation for over 90 years. The item is an integral part of the Davy assemblage. The item is impressive in size and form and exhibits a unity in its design and detail. The item has research and education potential for developing an understanding of early engineering practice. The item will yield information on the nature of past work practices. The item exhibits a high degree of structural integrity. Conservation Policy: The item is to retained in its present location and be preserved as part of the Davy assemblage and overhead crane collection to which it belongs. The item is to be reconnected to its power source and made operational. The item is to be preserved by being cleaned, serviced and maintained according to the implementation and maintenance schedules given below.

All externant rust is to such as	be remo	ces are to ved or trea VSIS fluid (ted. All or polycr	external surfa	ces are to . All mov	g appropriate methors be treated with an a ling parts of electric	appropriate sealant		
Mainten	ance Scl	nedule							
	Inspect all external surfaces for rust every 12 months. Where necessary, coat as recommended in the implementation section.								
Interpre	tation:

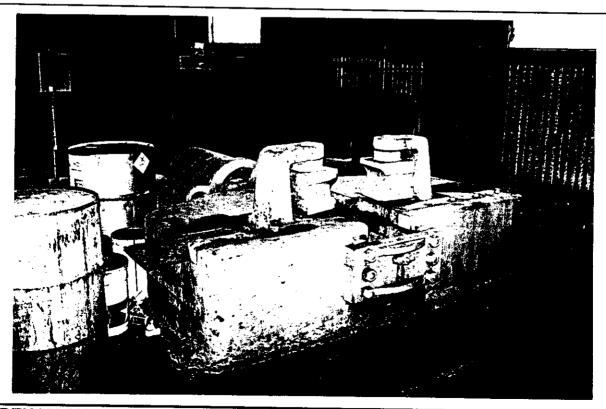
FILM No. 93-169-1-1

Maria Alexandria		CENTATION	1996
Item Name: Hydraulic Pipe Bender			Item No. 212
Name Plate:			
Associated Items:		-	
Individual 🗆			
Assemblage 🔲			
Collection			
System			
Operational Groups			
Description: The Hydraulic Pipe Bender of be described as over-designed. It has a hy two large rotating mandrels, dies in which the History: There is no information on the his	oraulic ram which is fitte le pipe is pressed.	ed with a return va	alve. There are
Function and Operation: The item was o		on: Bay 4A North	n E G E not
plumbers and coppersmiths. A pipe to	be bent was	Day 4A NOIL	1 5-6 East
In some cases the mandrel was made froregon. The hydraulic was allowed into	paped mandril. Om a block of the ram by		1 2 3 4
means of a lever and the mandrel moved which was supported against the dies a through the desired angle. The bent pipes	onto the pipe ind was bent were used for	X	6 7 8 9
a wide variety of functions throughout the w	orkshop.		10 11

Item Na	me: Hyd	raulic Pipe	Donder	······				
		aunc Pipe	Bender				Item No. 212	
Condition	on:	••						
the item	is cleane	d, serviced	d and tes	operable condited. The extended in the item of the ite	rnal surfac	iding power sources ar se of the item has pato iorating.	re connected and thes of superficial	
Significa	ance Mat	rix	. **		State His	storical Themes:		
	Historical	Aesthetic	Social	Technology/ Research Potential	Category	_	Industrial Relic	
Rare					Themes	☐ 13 Transport		
D						15 Utilities		
Repres-						☐ 16 Industry		
entative	–					☐ 18 Technology		
						20 Government Adm	inistration	
exhibiting is impres and educ yield info interpret	being associated with their operation for over 100 years. The item is a large, rare, industrial piece exhibiting massive cast-iron construction and which had general engineering application. The item is impressive in size and form and exhibits a unity in its design and detail. The item has research and education potential for developing an understanding of early engineering practice. The item will yield information on the nature of past work practices. The item and its operation is easy to interpret from its existing fabric. Conservation Policy: The item is to be relocated to any Bay except Bay 1-4A and preserved according to the Schedule below.

Policy In	-							
The mac internal b	hine is to are meta	be strippe I surfaces	d, all cyli are to be	nders cleaned dried and gre	l and dried eased to pr	l, all bearings and glar event rust.	ıds repacked, all	
rust is to	All external surfaces are to be cleaned and degreased using appropriate methods. All superficial rust is to be removed or treated. All external surfaces are to be treated with an appropriate sealant such as Shell ENSIS fluid or polycrystalline wax.							
Relocate	to any Ba	ay beside 4	4A .					
Maintena	ance Sch	edule					<u>, </u>	
Inspect a implemer	ll externa ntation se	l surfaces ction.	for rust e	every 5 years.	Where ne	ecessary, treat as reco	mmended in the	
Interpret	ation:

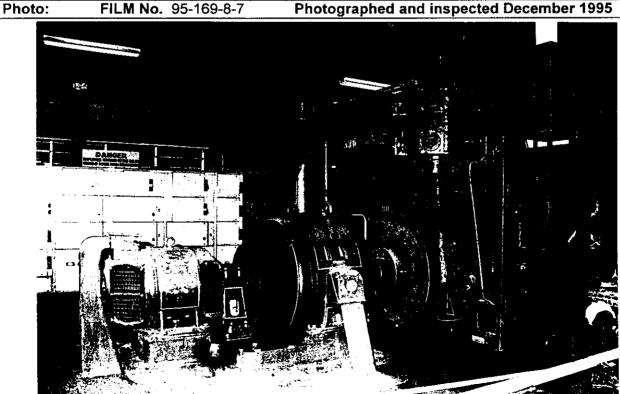
Item No. 214 Item Name: Air Compressor - Atlas Copco. Twin Two Stage

Description: The Atlas Copco is a 90 degree twin two stage air compressor run by an integrated ASEA electric motor of 50 horse power. The motor is direct coupled to a gear box unit on top of which is mounted on the large vertical piston of the primary cylinder. Air is brought to this via a 15 inch (375mm) steel welded pipe which discharges into the top cylinder. The compressed air is then passed directly into an inter-cooler which cools the air and is mounted immediately above the second stage piston. The air enters the second stage piston and, from there, passes into the main header pipe and to the air receiver.

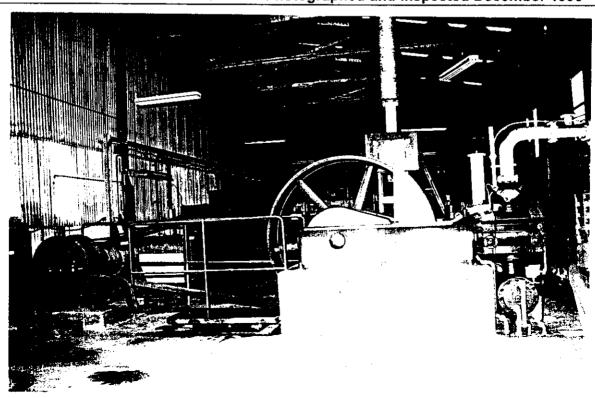
Photo: FILM No. 95-169-8-0 Photographed and inspected December 1995

Description: This is the largest machine in the shop and is about 9 metres long, including the belt, which drives the machine from the stand-alone motor. The compressor foundation is about 3.5 metres wide and it stands in excess of 3 metres high, including the safety valve and the exit pipe. Air enters the No.1 cylinder through an adjacent pipe which has a simple cylindrical screen to keep out unwanted solids. The partially compressed air passes through the inter-cooler into the smaller second piston and thence to the header pipe. The valving on this machine is operated by shaft and the whole of the machine is of mechanical rather than electrical design. It is believed that the valving on this is of the simple D-type. There is no date on the machine but it is believed to have been manufactured about 1914. The fabric belt is 450mm wide and the fly-wheel 2.3metres in diameter. It would appear to weigh in excess of 2 tonnes. The electric motor, which drives the compressor is of 50 horsepower. The switch gear is contained in a small cabinet adjacent to the motor and has the insignia WB Williams & Bennett Pty Ltd of Melbourne, Victoria. Like all the switch gear in the building it has an on-off switch for both the pump, the fan, as well as for the compressor.

Item Nam	tem Name: Air Compressor Ingersoll - Rand. Co New York, USA Imperial Type 10. Parallel Twin 2 Stage						
turned ov	er and o	perated with	a minir	nal amount of	f service.	 d. It is believed that the However, it should be operated prior to being 	noted that no air ['
Significa	nce Mat	rix		•	State His	storical Themes:	
	Historical		iocial	Technology/ Research Potential	Category	☐ Moveable Item ☐	Industrial Relic
Rare					Themes	13 Transport	
_						☐ 15 Utilities	
Repres-	rø	×		×		16 Industry	
entative	×	<u>. </u>	_			☐ 18 Technology	inintantion
					1	20 Government Adm	inistration
The item operation understa existing f	was an for ove nding of fabric. T	er 60 years. early engine he item exhi	The i ering p	tem has rese	earch and item and it	Norkshops being asso education potential for s operation is easy to integrity.	or developing an I
Conserv		_					
recomme recomme end of B	sors sim ended th lav 1 or	ilar to this we at this item to other suitab	ere ofte oe remo le locat	n driven from wed to the Lo ion in a suital	Tine shafts comotive V bly constru	type, having horizonta or by stand-alone stea Vorkshops and be inst acted cabinet. The ite am system into operation	am engines. It is alled at the north m could then be

Policy Ir	npleme	ntation:					
Before ir determin its install	ied. If th	ne item is in	icy, it is the cor	s essential thandition it is be	at the item lieved to b	n be stripped and its per then design work ca	precise condition in commence for
Mainten	ance Sc	hedule					
The item qualified		stalled in Ba	ay 1, w	ould be main	tained acc	ording to a schedule	determined by a
Interpre	tation:				<u> </u>		
meibie	tauvii.						
1

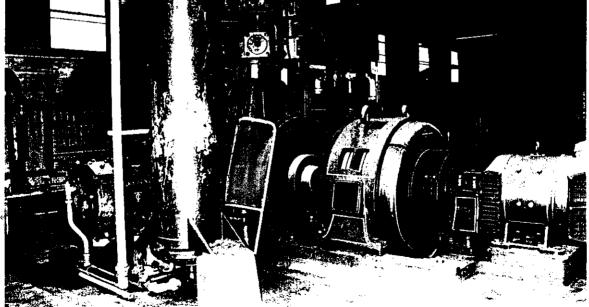
FILM No. 95-169-8-6

Description: This air compressor has a stand-alone motor with an attached starter motor. The starter motor is direct coupled to the main motor and the brushes of the main motor are open with a mesh cover. The large inter-cooler is vertical and is placed on the south side of the second cylinder. Air enters the primary cylinder through a 250mm pipe via the roof, passes to an air filter and then to the vertical No.1 cylinder. The whole machine is of massive cast-iron construction bolted together. There is the most impressive power panel at the end of the machine against the south wall. It contains a start switch for the pump, fan and the compressor. This machine, like all others, is fitted with an emergency stop.

Item Name: Thompson 90 Degree V Twin 2-Stage Compressor Item No. 216										
Conditi	on: The	condition o	of this ma	chine is susp	ect It app	ears that work was col	mmencing for its			
overhau	Condition: The condition of this machine is suspect. It appears that work was commencing for its overhaul when the Workshops were closed down and the machine is partially disassembled.									
Signific	Significance Matrix State Historical Themes:									
	Historical	Aesthetic	Social	Technology/ Research	Category	☐ Moveable Item ☐	Industrial Relic			
_	-			Potential		_	muustnai Kenc			
Rare					Themes	☐ 13 Transport☐ 15 Utilities				
Repres-						15 Othlities 16 Industry				
entative	×	×		×		☐ 18 Technology				
						20 Government Admi	nistration			
Stateme	ent of Sig	nificance			<u> </u>	<u> </u>				
The iten operation potential	n was an n for ove l for deve	integral pa r 40 years. loping an u	The ite Inderstar	m was producted and make make make make make make make make	ced in Aus engineerin	Vorkshops being assortralia and has research g practice. The item a high degree of structu	n and education and its operation

Conserv	ation Po	olicy:								
The item	is to be	retained i	n its pre	sent location a	and be pre	eserved as part of the	air compressor			
collection	n to whicl	n it belongs	,		•	8.: 77' 21.				
The iter impleme	n is to ntation a	be preser nd mainten	ved by ance sch	being cleane ledules given l	d, service pelow.	d and maintained ac	cording to the			
Policy I	nplemen	tation:	-							
determin	Policy Implementation: It is essential that this machine be stripped by a qualified fitter and that its precise condition be determined. The item is to be greased and reassembled and covered with a suitable textile to prevent pollutants falling on the item.									
Mainten	ance Scl	nedule								
If the iter	If the item is left in this position it should be inspected by a qualified fitter every 12 months.

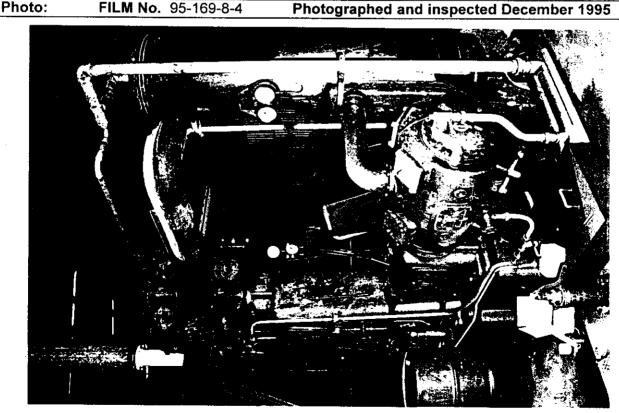
The cabinet containing the transformers for this item is immediately to its south. These cabinets contained the usual array of circuit breakers under current control and feed the excitor, the motor and the small water pump which pushed the circulating water through the system.

Item Na	ame: Tho	mpson 90	Degree \	/ Twin 2-Stag	e Compres	ssor	Item No. 217
				n appears to l	be good ar	nd it is believed that, w	ith a service, the
machin	e would b	e operable	!.				ŧ
Cianific	ance Ma		··· ·	•	C4-4- 11:	4-1-1-76	
Signine	Historical	Aesthetic	Social	Technology/	l	storical Themes:

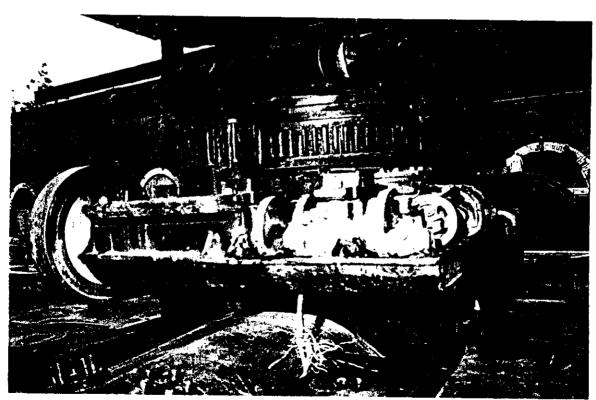
Slewing motor and turret of jib.

- The tray beneath the smoke box should be cleaned by abrasive blasting and should be sealed with a two pot epoxy paint.
- Slewing motor should be stripped, re-greased and, where necessary, painted. All bright parts should be coated with polycrystalline wax after removal of corrosion. The drain pipe on the slewing motor should be repositioned so that water is drained away from the tray.

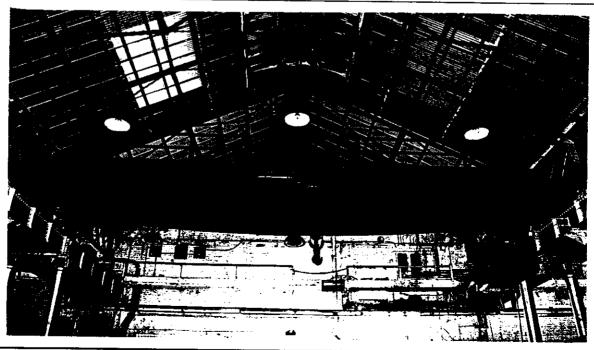
Photo: FILM No. Photographed and inspected December 1995

Description: All of the cranes have twin crane beams made from box, plate or lattice girders. Each has a small carriage which runs on the upper surface of the beams and supports the transverse motion, the cable drum and the cable drum/motor. Longitudinal movement of the crane is via the longitidunal motor which is generally mounted on a bracket attached to the leading crane beam. Each crane has a small cabin, slung below the crane beams. The cabin contains a fuse box and three controllers, one for each of the longitudinal travel, transverse travel and hoist mechanisms. Power for each crane is via six cables which run on insulators along the western crane beam of each bay. Most of these power cables appear to be intact, but they have all been disconnected from the electricity power supply.

Item Na	ame: Elec	tric Overh	ead Trav	elling Cranes			Item No.219a-h	
Condit	ion: All ap	opear to be	e in opera	ative condition	Some ha	ive superficial rust.		
Signific	cance Mat	trix Aesthetic	Social	Technology/	State Historical Themes:			
		,,,,,,,,,,,,,,,,,,,,,,,,,,,,,,,,,,,,,,,	4 00.a.	Research Potential	Category	Moveable Item	☑ Industrial Relic	
Rare	X			X	Themes	☑ 13 Transport		
Repres-	v			•		区 15 Utilities 区 16 Industry		
entative	×	×	×	X		≥ 18 Technology		
						20 Government A	dministration	
Statem	ent of Sig	nificance		··········				
The cranes were an integral part of the Eveleigh Locomotive Workshops being associated with their operation, in some cases, for almost 100 years. The items are an integral part of the Workshops operations. The cranes are impressive in size and exhibit a unity in design and detail which is now rare. All cranes have research and education potential for developing an understanding of early engineering practice and each crane is an easily interpreted item. The cranes all exhibit a high degree of structural integity and all will yield information on the nature of past work practices.

Conser	vation Po	licy:						
Each item is to be retained in its present bay and to be conserved as part of the Eveleigh Locomotive Crane Collection to which it belongs. Each crane is to be preserved by being cleaned and serviced according to the maintenance schedule given below. The electric power cables above each of the western crane rail beams are to be preserved.								
Policy Implementation:								
All external surfaces are to be cleaned and degreased using appropriate methods. All superficial rust is to be removed or converted. All external surfaces are then to be treated with an appropriate sealant such as Shell ENSIS Fluid or polycrystalline wax. The moving parts of the electric motors are to be covered to prevent ingress of dust. Exposed gear trains are to be covered to prevent ingress of dust.								
Each crane may be re-positioned in the bay in which it is located.								
Maintenance Schedule

All external surfaces are to be checked for rust, every 12 months. Where necessary, surfaces are to be treated as recommended in the implementation section of this report.								
Interpretation:
