Redfern Local Area Command  
**Waterloo Green Safety Audit**  
14 June 2007

# Executive Summary

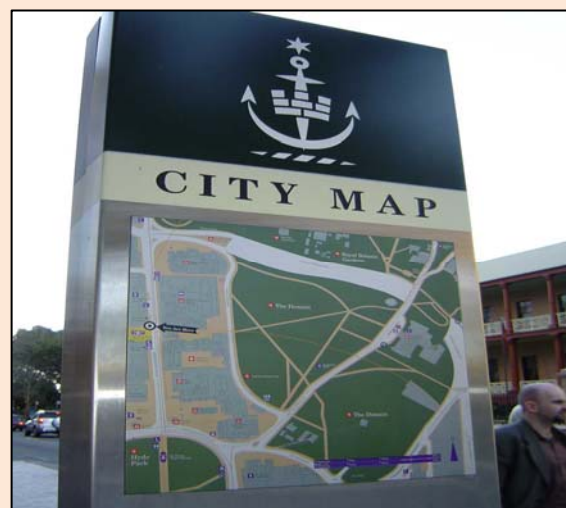
Signage in the audit area was identified as being inadequate. Nearly all of the signs were damaged, vandalised or non-existent. In many cases advisory signs were poorly positioned and could not be easily read. No community information signs, notice boards of maps were available to assist the public in locating services.

- All vandalised signage be removed.
- The type, style and positioning of signage reviewed as to its appropriateness and according to CPTED principles.
- A program of regular maintenance to ensure that damaged and vandalised signs are replaced or repaired within a short time frame.

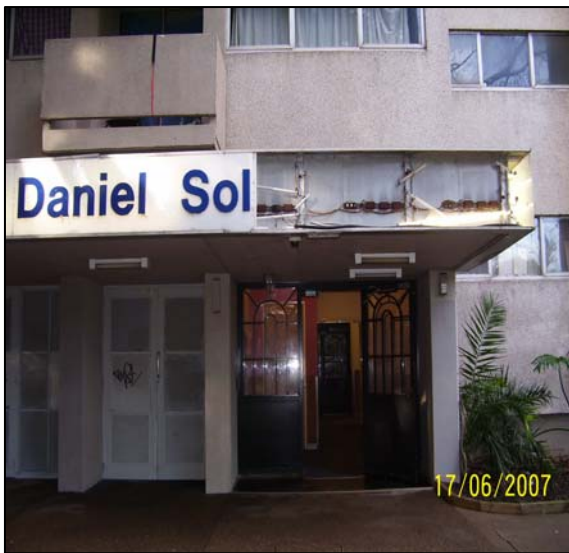
- Vandalism can induce fear and avoidance behaviour in public spaces. The act and outcome of graffiti can reward offenders. The display of one's handywork to others can be a strong motivation to repeat the behaviour. The longer 'tags' are left on display, the greater the reward and repetition will occur. A graffiti management plan is recommended.

- Rapid removal has proven to be a successful long term graffiti management strategy where graffiti is removed within a 24-48 hour period.
  - Graffiti vandals favour permeable building surfaces as 'tags' are more difficult to remove and often a ghost image will remain

- even after cleaning. Graffiti resistant materials are recommended particularly on ground floor levels of buildings.
- An organised graffiti removal program by community groups provides a means for the community to build cohesion, ownership and to remove fear inducing area features.
  - The use of vandal resistant surfaces for seating, tables and the playground equipment is recommended.
